HVTS PREVENTS CORROSION ATTACK IN A REGENERATOR COLUMN AT LNG PLANT IN GCC

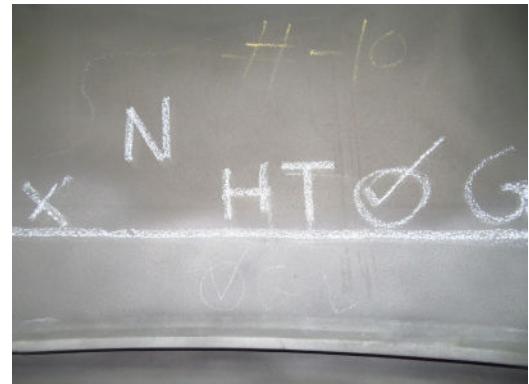
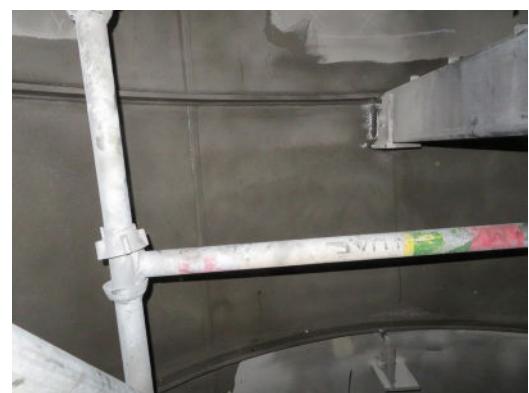
HVTS cladding applied on internal shell

Once the surface was prepared correctly, IGS applied its own uniquely developed High Velocity Thermal Spray (HVTS) cladding, with more than 40m² of IGS HVTS cladding applied onsite, on time and at the highest quality standard.
