# 5 Common Causes of Refractory Failure and How to Fix Them

## Case Study: Fired Heater Shutdown Prevented with Hot Refractory Repair

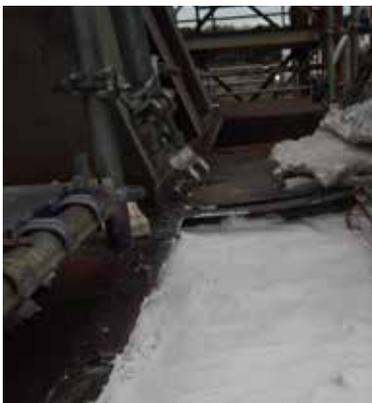
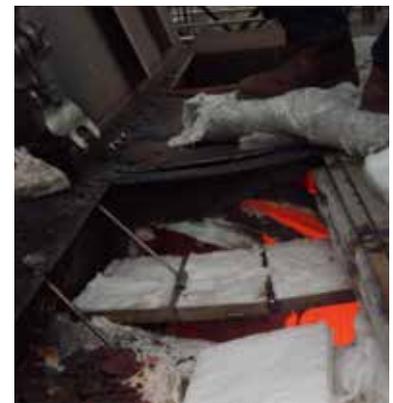
**Hot-Tek #1 & #2 Repair Area.**  
Repaired using Hot-Tek Module Style on the ceiling of the installed dog boxes.

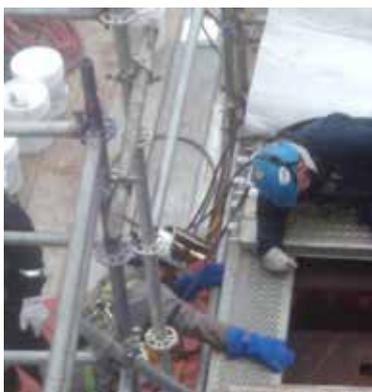
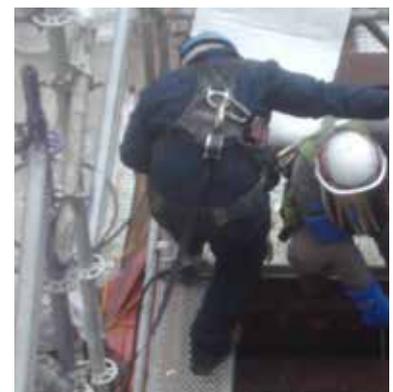
**Hot-Tek #3 Repair Area.**  
Repair performed utilizing the Hot-Tek Basket Style Repair on the existing ceiling.

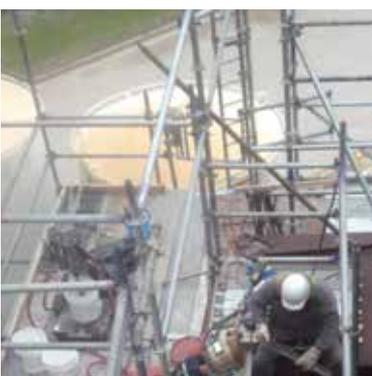
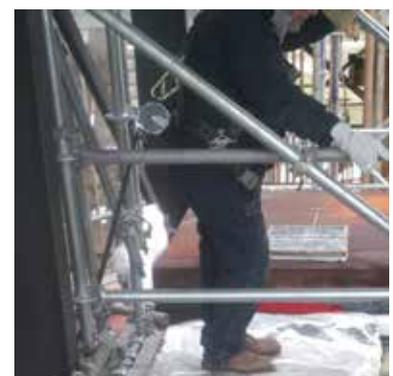
**Hot-Tek #4 Repair Area.**  
Repair performed utilizing Hot Tek Basket Style Repair on the side of the Dog Box and existing ceiling.
