HVTS PREVENTS CORROSION ATTACK IN A REGENERATOR COLUMN AT LNG PLANT IN GCC

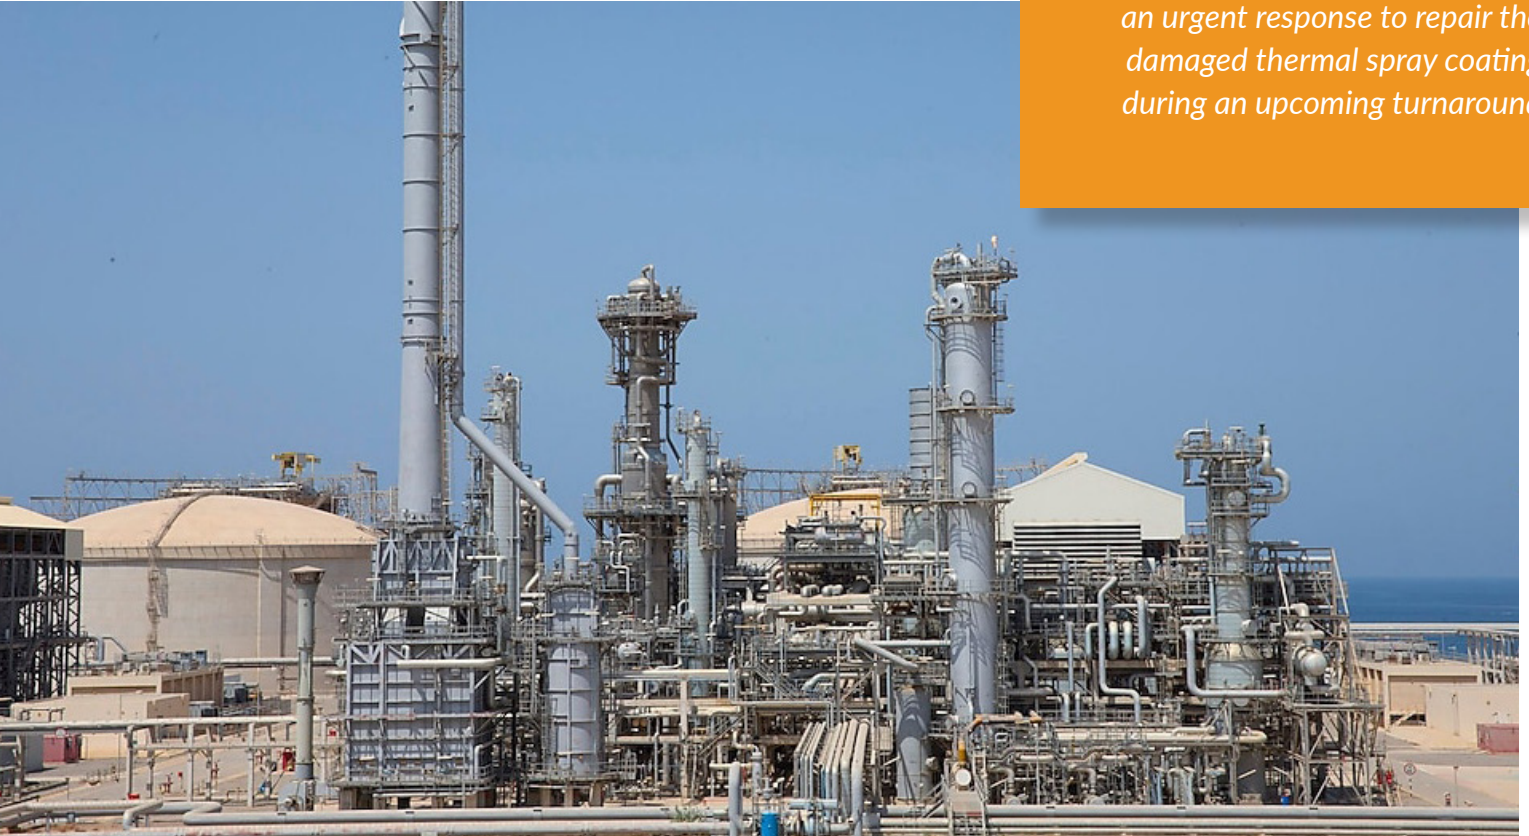
An application of conventional thermal spray coating had led to failures, so the plant required an urgent response to repair the damaged thermal spray coating during an upcoming turnaround

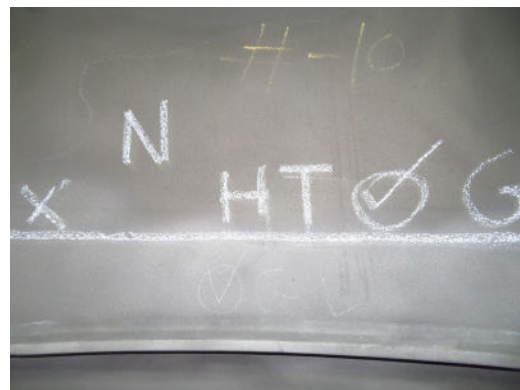
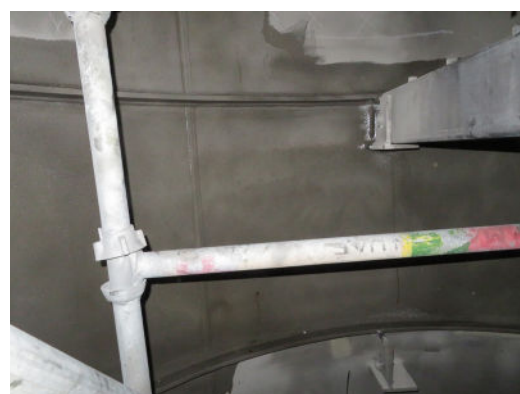
HVTS cladding applied on internal shell

Once the surface was prepared correctly, IGS applied its own uniquely developed High Velocity Thermal Spray (HVTS) cladding, with more than 40m² of IGS HVTS cladding applied onsite, on time and at the highest quality standard.
