How to Stop Forced Outages and Reduce Production Losses

in Mineral Processing Facilities

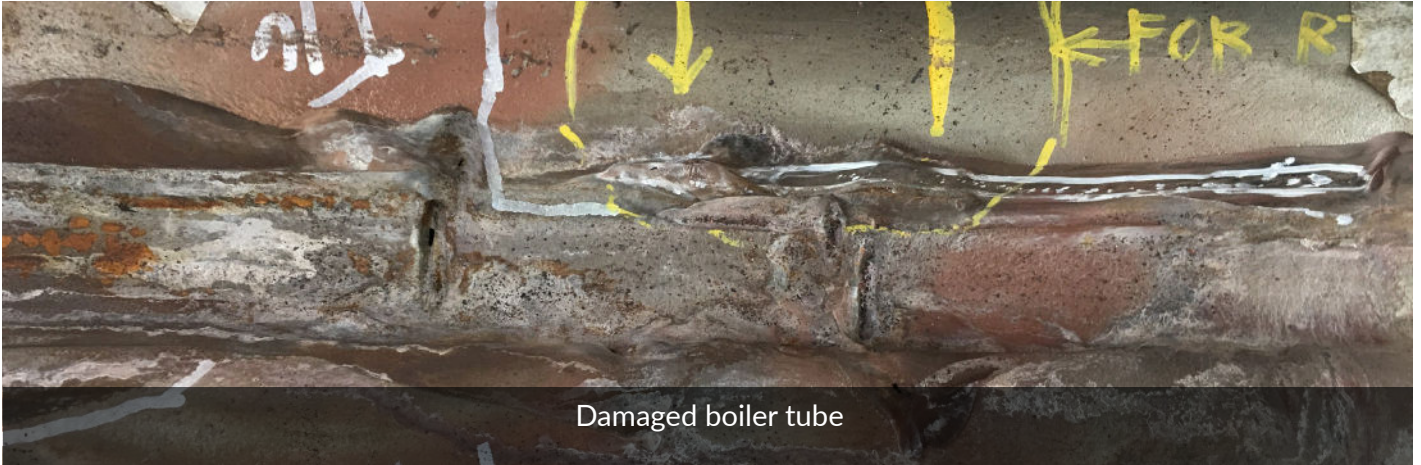
Damaged boiler tube

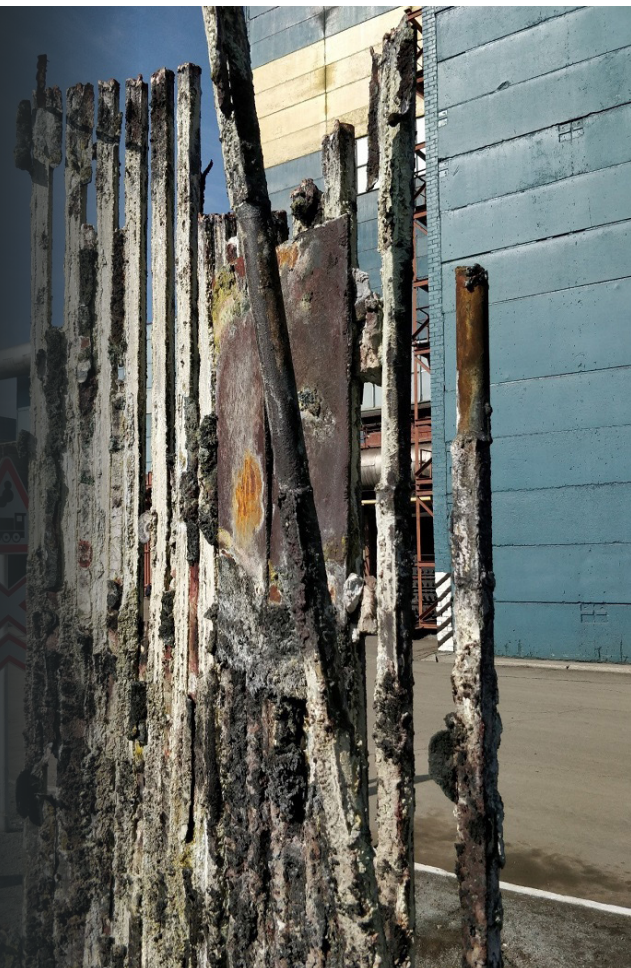
On the right is a WHB example that gets replaced every 24 months due to rapid degradation of the pressure parts.

Some plants elect to replace the whole waste heat boiler periodically. This can happen as frequently as every 24 months due to the aggressive nature of the feedstock and process.

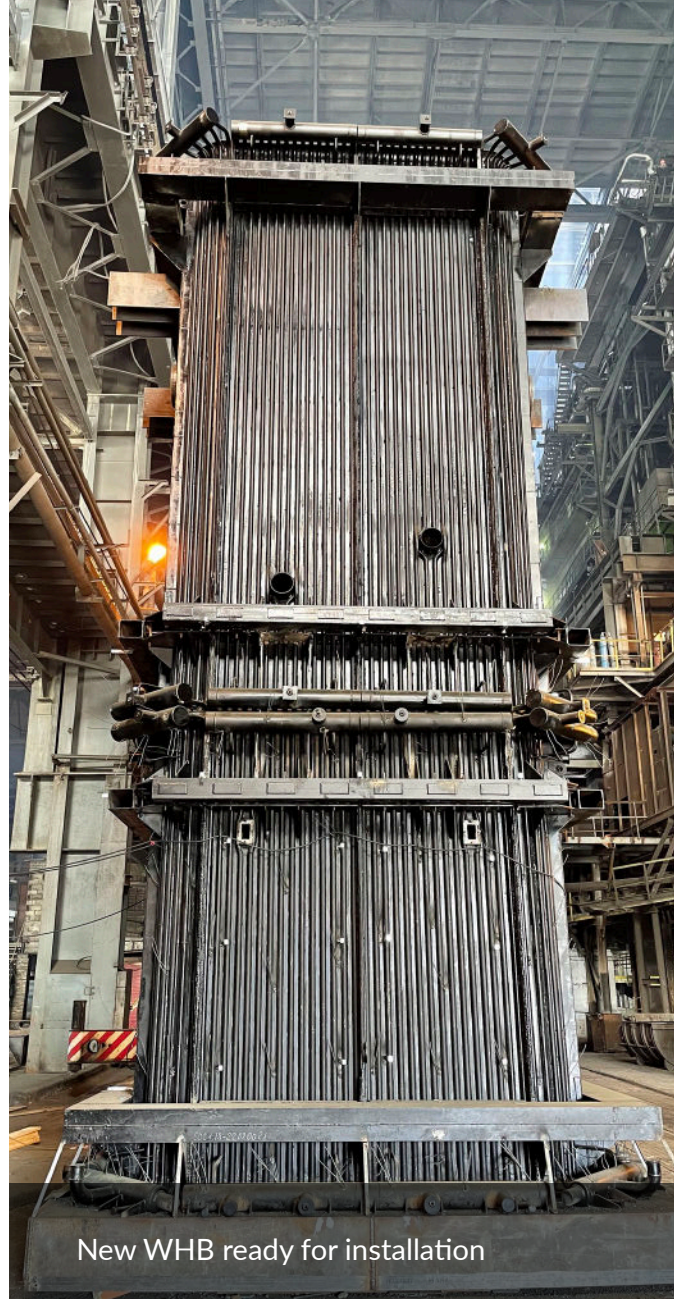
New WHB ready for installation
