Mitigating Corrosion/Erosion in Waste to Energy and Biomass Boilers

Comparing the effectiveness of commonly used technologies, including refractory, weld overlay, thermal spray and high velocity thermal spray

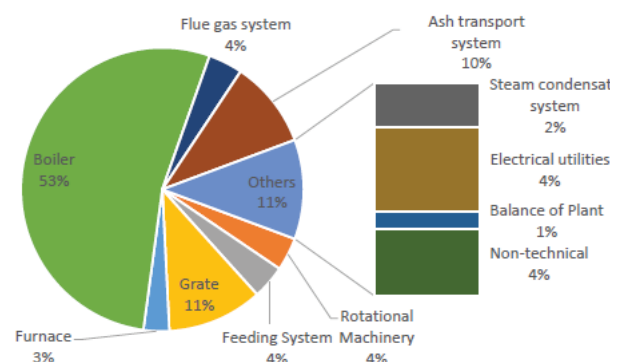
Root Cause Unplanned Outage

1. Emergency work. The line is stopped, conditions to complete the repair under time constraints are unfavorable. Oftentimes, this extra work can occur in the middle of the night, on a weekend or during a holiday period, adding unnecessary stress for the operation and maintenance teams.
2. Financial losses. Several days are required to remedy the problem, leading to sizeable production losses.
3. Emissions. Stop-and-start phases are known as periods with higher emissions, since the gas filtration system doesn't operate within its design parameters. Exceeding emissions can potentially lead to losing the license to operate.
4. Faster aging of the unit. Frequent stops and starts create additional thermal cycles on the entire boiler for which it was not designed, accelerating the fatigue aging of the components under stress.

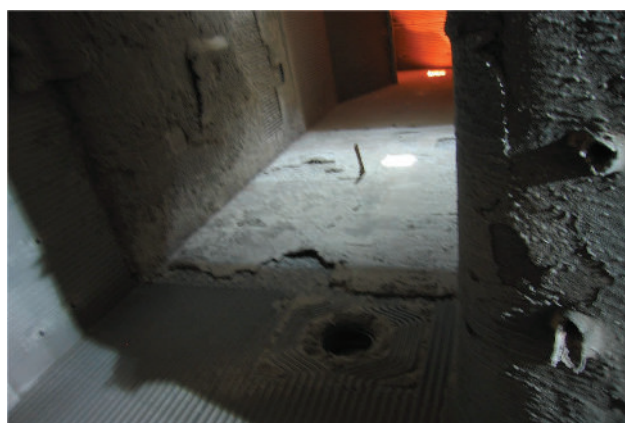
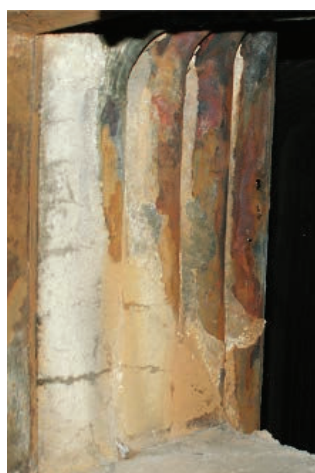
Almost New Refractory

Refractory effectively protects the waterwalls but, due to its low heat transfer, even the latest generation materials reduce heat transfer significantly.

Refractory maintenance costs tend to be high and usually drive the duration of the outage. Refractory can also degrade and fall off in service, exposing unprotected boiler tubes to the severe operating conditions, leading to rapid failure. After the installation, drying times and heat ramp up are also critical.

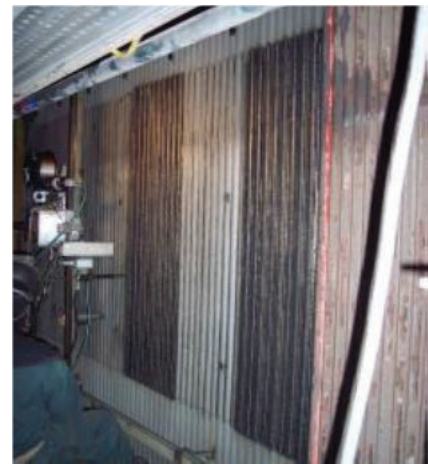
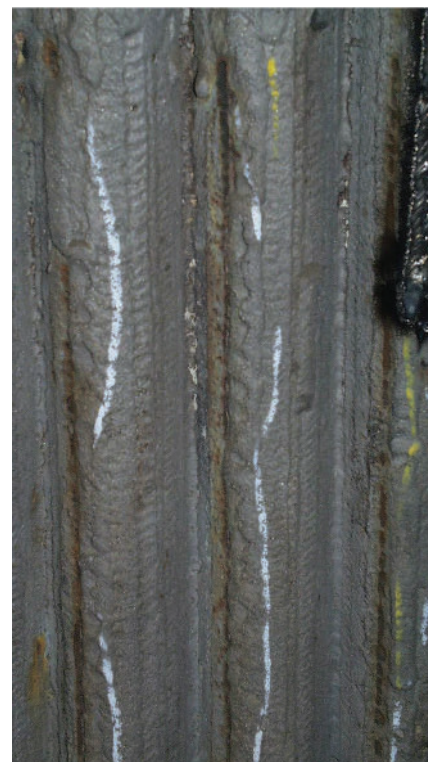
Field services – on site weld overlay

Weld overlay emerged as a new solution ~25-30 years ago, developed for WtE plants suffering from reduced waterwall tube life. Several materials were evaluated and alloy 625 provided the best results with relative ease of in-situ application and life extension reliability, despite its high cost. As the demand grew, several suppliers entered the market with different quality/price ratios. Competition and pressure from the end users have ultimately drove the prices down, leading to the reduction in quality. As a result, low-priced providers were selected with some disappointing results:

1. Shortened weld overlay life (high dilution)
2. Wall distortion due to weld generated stress (high heat input)
3. Execution time longer than planned (especially in cases of thin tubes)

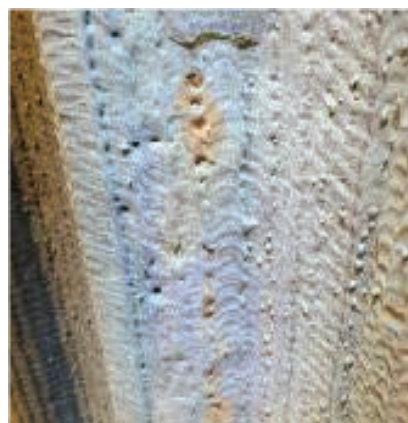
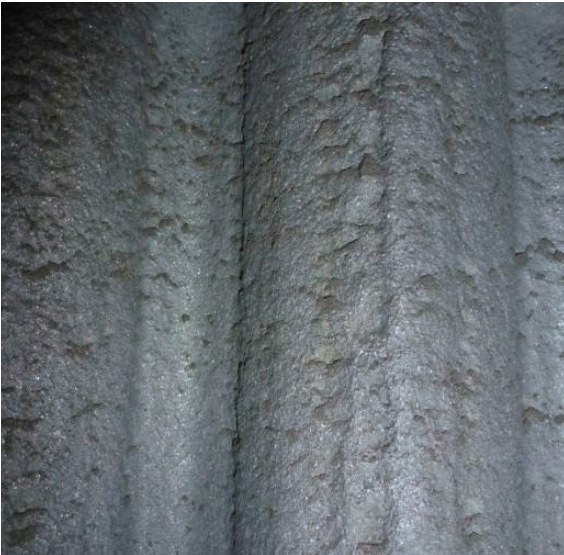
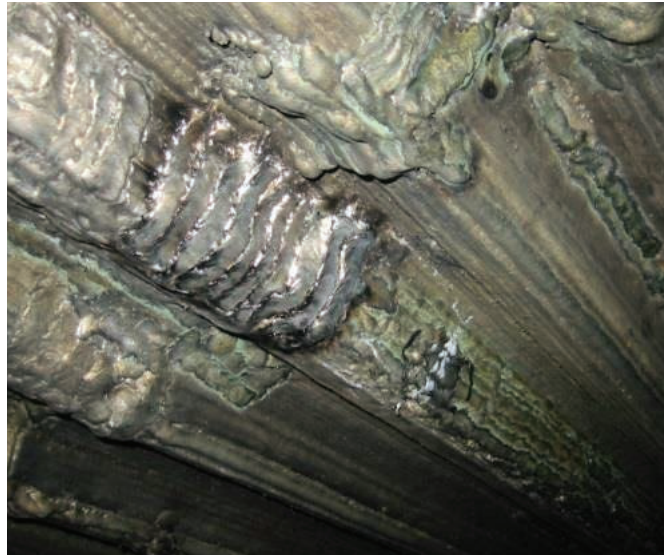
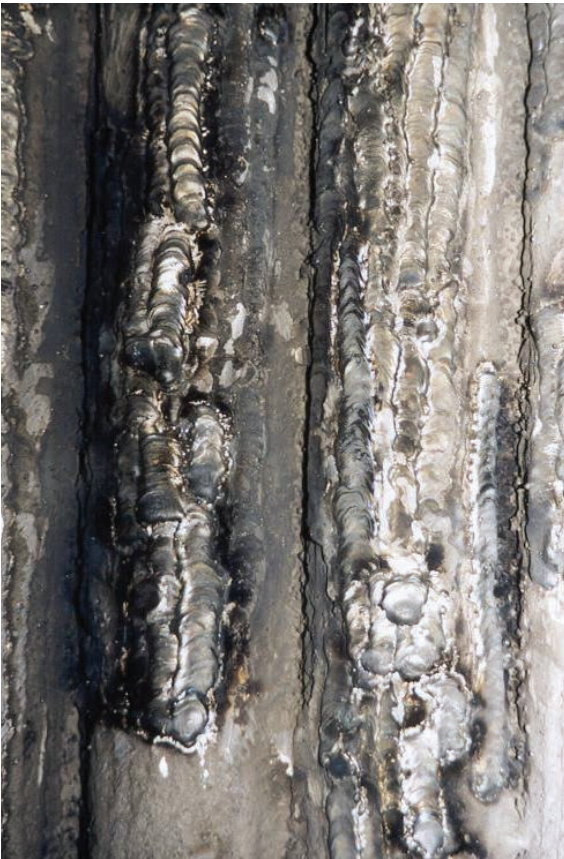
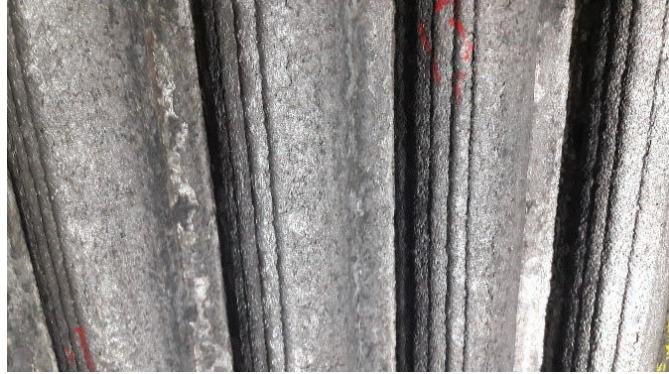
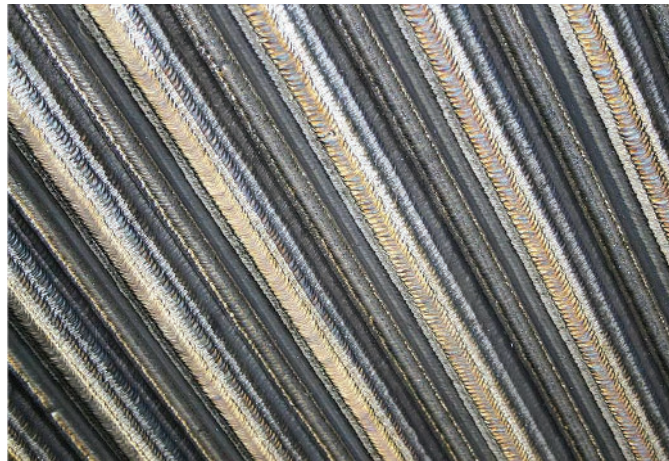
Shop weld metal overlay

Alloy 625 performs exceptionally well at temperatures up to 400°C/752°F. Above this temperature, the lifetime is reduced by half with every 10°C/18°F increase

After years in operation alloy 625 weld overlay will also age. Typically, the surface becomes “spongy”. Chromium forms chromium oxide layers to protect from corrosion, but this layer gets worn and reformed until the layer of alloy is “consumed”. The phenomenon is not uniform, consequently some areas will age faster than others.

Weld overlay can be repaired, provided that surface preparation can be carried out to remove the “aged” material. This operation, usually performed by grinding, is time consuming. It can be performed locally to “maintain” the barrier, but once the aged surface is too large, the replacement with new shop-applied weld overlay panels or other protection means needs to take place.

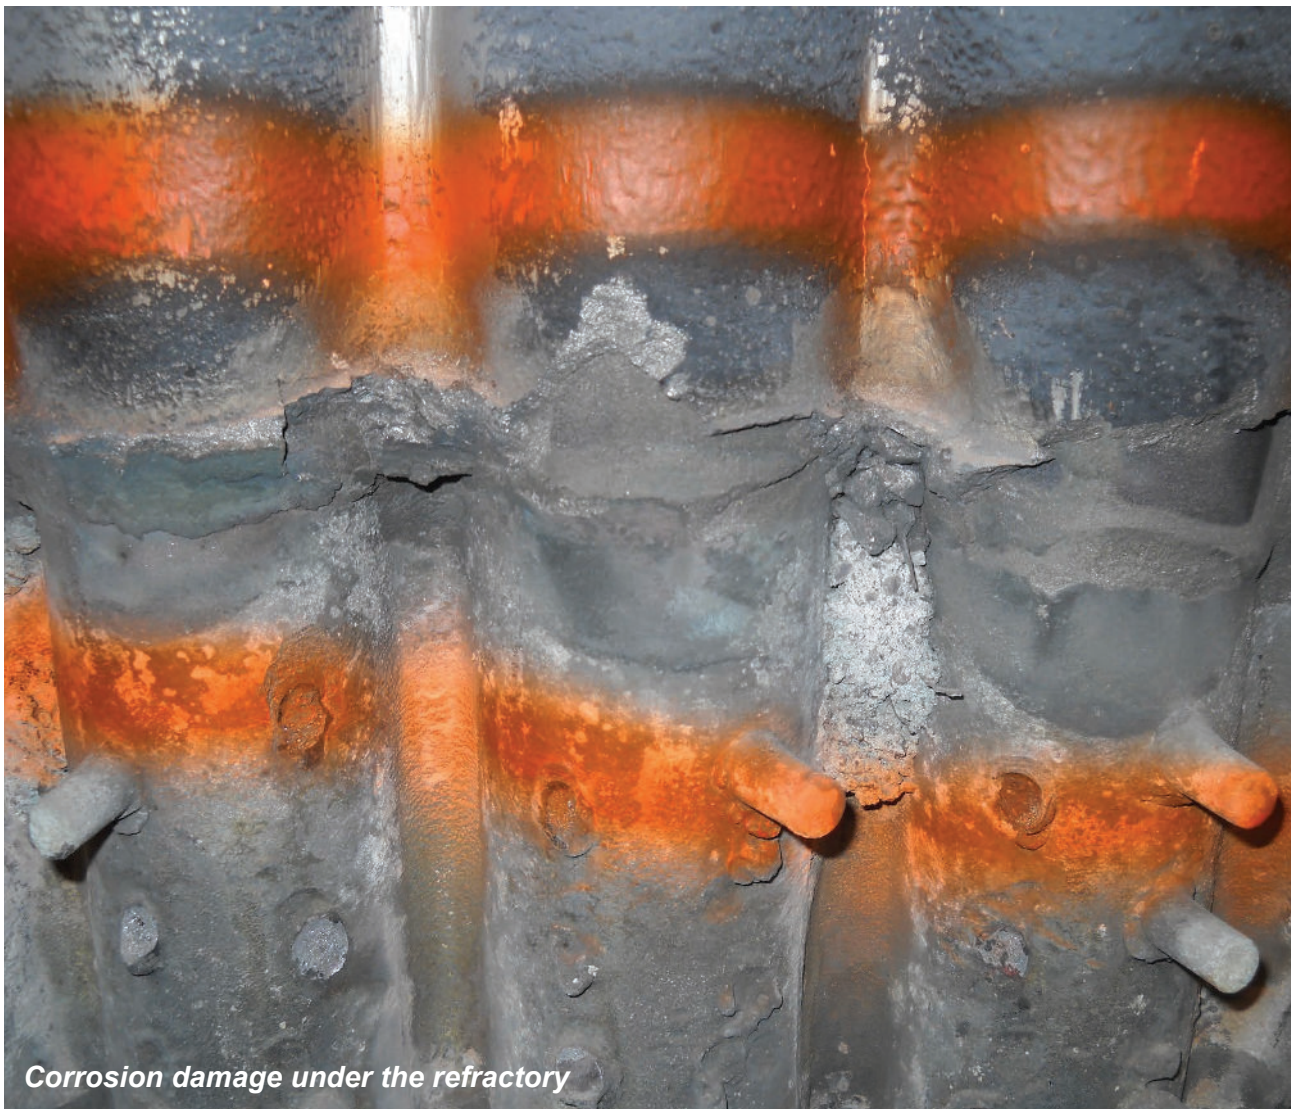
Corrosion damage under the refractory

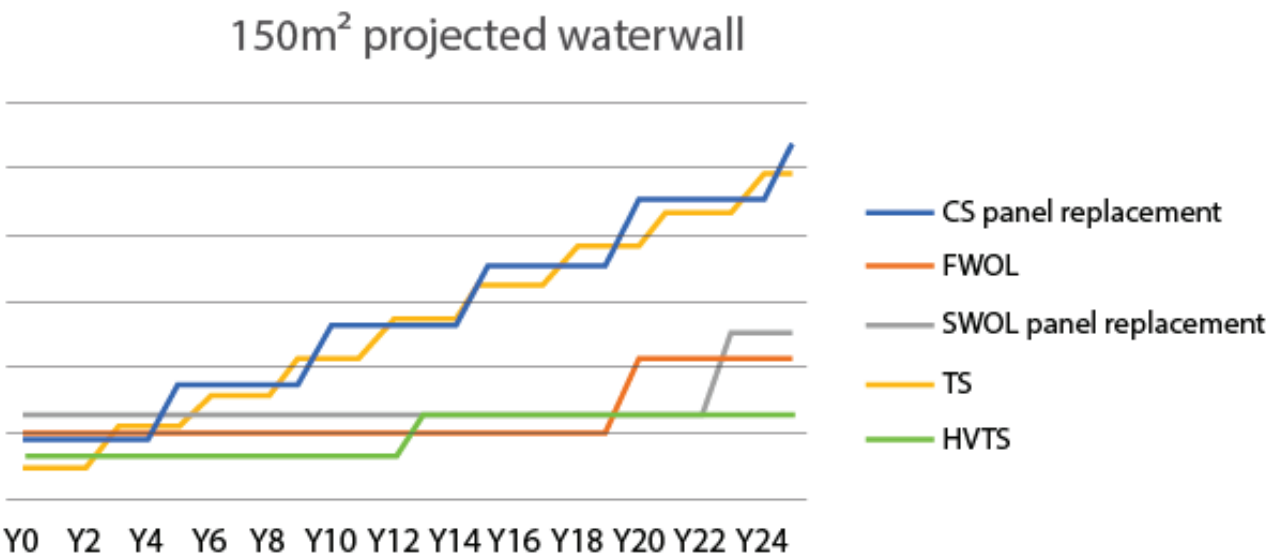
The following table gives indication of the cost versus return on investment of various solutions for a projected surface 150m² area. The cost can vary slightly based on the location, while the lifecycle may vary significantly based on location, fuel, boiler design and other influences. Life cycles for the different options relative to each other remain somewhat consistent though.

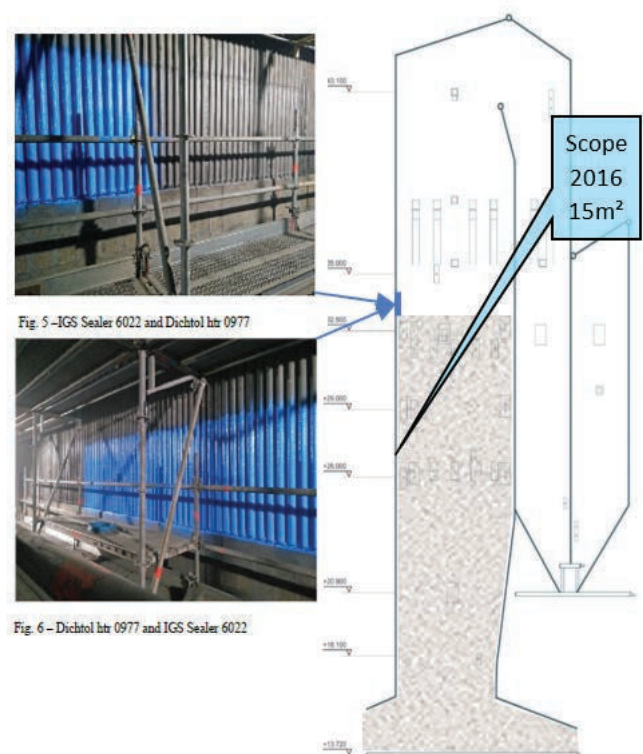
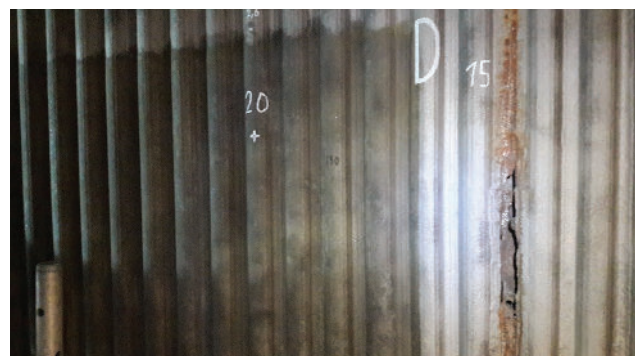
- Unprotected alloy 625 weld overlay continued to degrade, with through-wall defects on the membrane
- Alloy 625 areas protected with IGS8000 series, a material previously developed for the coal power sector, were exposed
- Alloy 625 areas protected with IGS5000 series, a material developed specifically for the WtE and Biomass industry in 2016, showed no signs of wear or degradation. IGS5000 series was unaffected with no spalling or degradation, even on the membranes, after 32 months in service.

The test application of IGS HVTS was performed for one of the largest WtE plants that treats over 1.400.000 tons of waste per year. The plant was experiencing accelerated degradation of their weld overlay cladding in the 1st path, just above the refractory. Looking to avoid panel replacement, the plant has elected to trial two HVTS alloy cladding solutions, IGS8000 and IGS5000 series materials, in 2016 with a 15m² application.

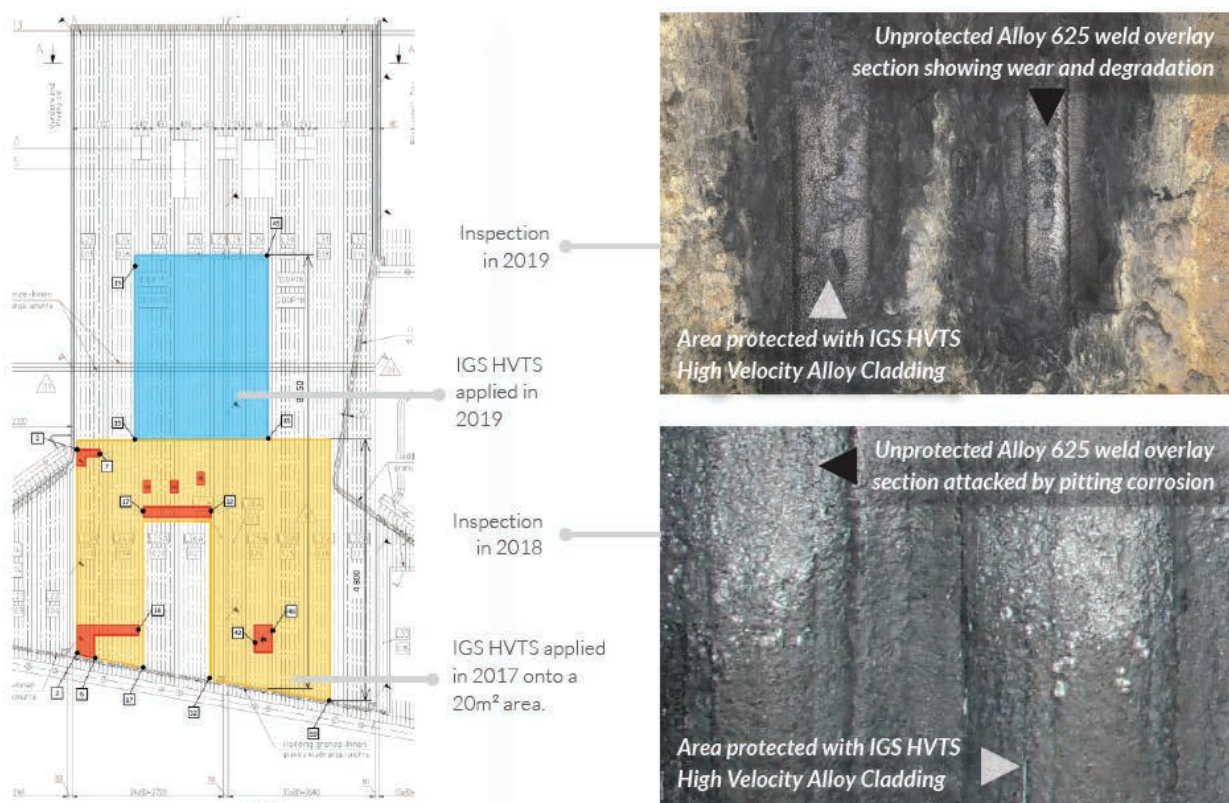
As a result, Renergia has elected to test four thermal spray vendors. Each was given a small area within the boiler, performance was evaluated after one year in operation, during the next turnaround. Two of the vendors who used a low velocity thermal spray process have failed as their cladding delaminated and exposed alloy 625 to further degradation. IGS 5000 series and another cladding, both using the High Velocity Thermal Spray (HVTs) process have performed well. Due to the other vendor's capacity limitations, IGS was awarded the contract in boiler protection.

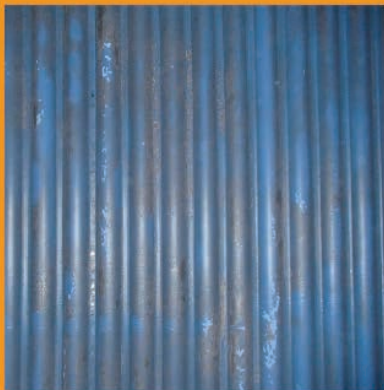
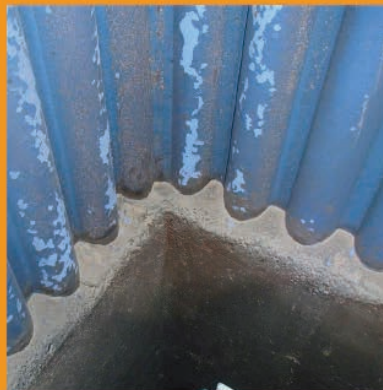
2018 INSPECTION

In August 2018, IGS conducted its first annual inspection of the cladding with no deviation on the HVTs cladding thickness. Inspection the following year was conducted, and the report stated: "No black areas were detected (bleed through), the cladding turned out to be completely intact and without material loss. Measurements taken showed results similar to those from the year of application." Inspections in 2019 and 2020 showed no corrosion, ~1m² (0.1% of the total area) was refurbished in 2019 and 2020 due to normal erosion near refractory and field weld areas.
