TEXAS TOWER (VCFE) CLEANING ENABLES IRIS INSPECTION AND SAVES \$8MIL+

Texas Tower (VCFE) Fouling

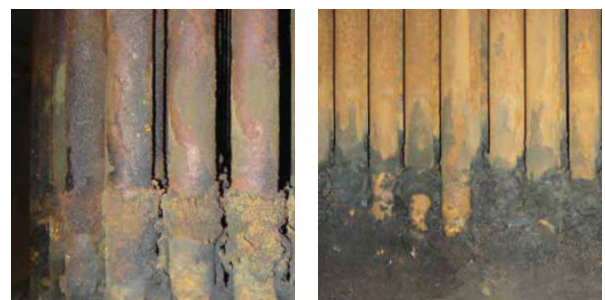
Shell Side Fouling Showing Corrosion and Hard Coke Deposits

VCFEs were originally designed not to foul. However, over several decades these units have often been pushed to the limits or have been subject to inadvertent carry over such as catalyst and oil on the shell side as well as the usual buildup of polycyclic aromatics, gum-like deposits and very hard hydrocarbon coke scale.

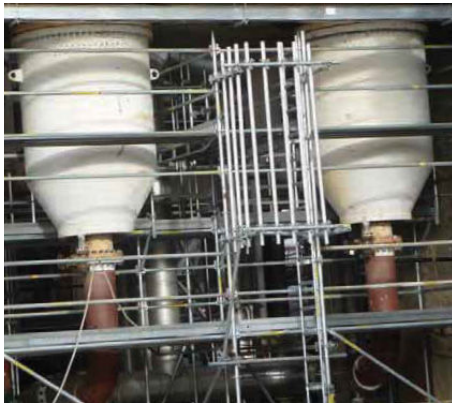
Twin VCFE Texas Towers

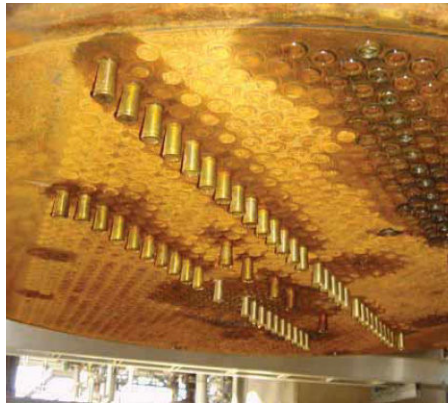
Tubes Marked for Enhanced IRIS Inspection Cleaning

- 1434 tubes per exchanger, total 2868 tubes.
- 100% of tubes to be cleaned to production standard.
- 10% of tubes to receive enhanced cleaning ready for IRIS inspection.
- Deposit characteristics: rubber, chewing gum consistency, polycyclic aromatics, hydrocarbons, hard inert coke and ferrous oxide scale.

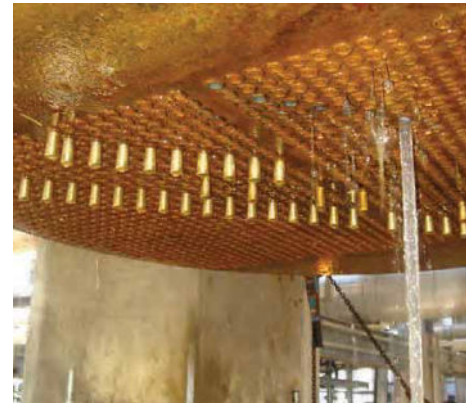
Tubes Running Clear After Enhanced Tube Tech Cleaning

IGS set up bespoke Tube Tech cleaning technology to access the tube face to drill, descale, polish and inspect the tubes. During the cleaning, projectiles left behind by previous contractors were identified and removed.
