TUBE TECH REINSTATES HEAT TRANSFER EFFICIENCY AT AN ETHYLENE FURNACE

Ethylene Furnaces

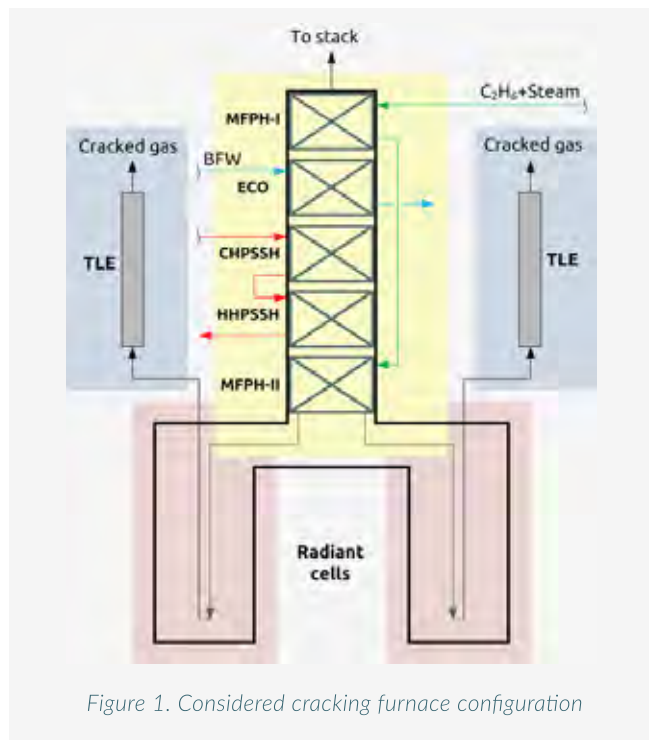
Figure 1. Considered cracking furnace configuration

The convection section is located above two fireboxes. The services of the different heat transfer banks shown in figure 1 include:

- Mixed Feed Preheater (MFPH-I);
- Economizer (ECO);
- Cold High-Pressure Steam Superheater (CHPSSH);
- Hot High-Pressure Steam Superheater (HHPSSH);
- Mixed Feed Preheater (MFPH-II).

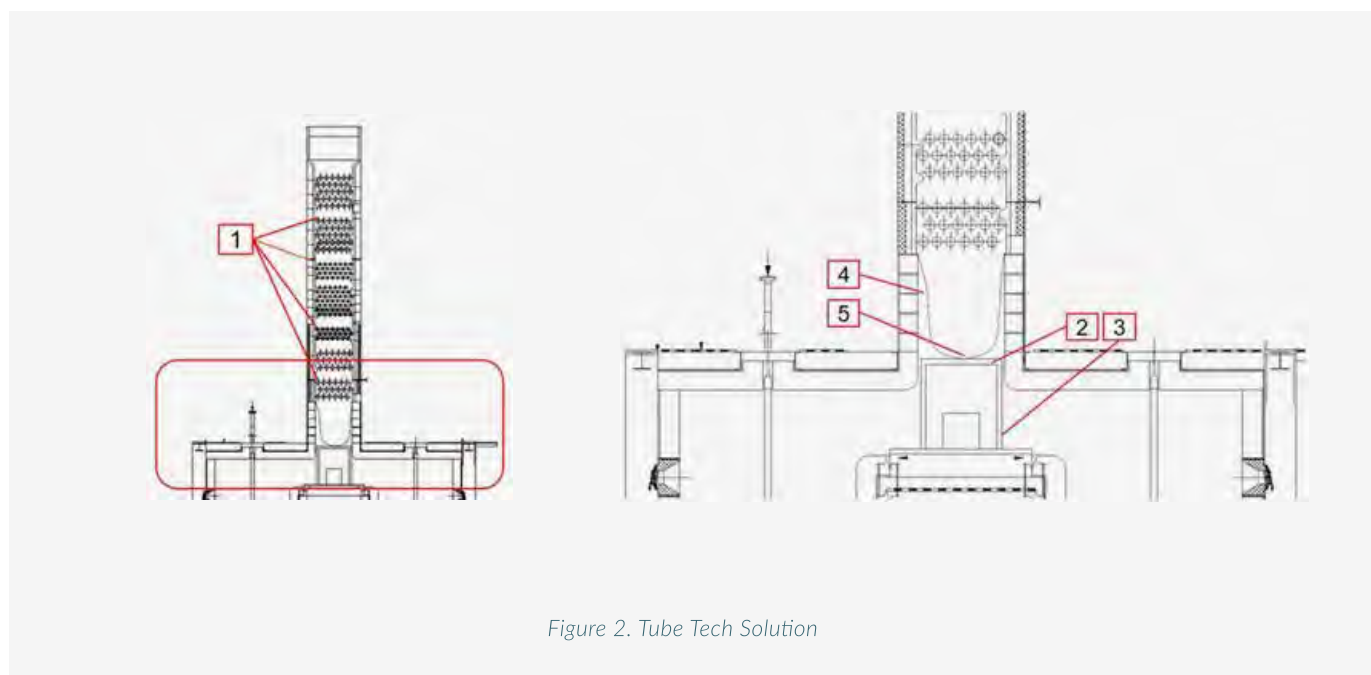
Figure 2. Tube Tech Solution

To perform effective heat transfer restoration using a unique Remotely Operated Vehicle (ROV) fouling removal technology and protect the existing equipment from water exposure, the following three steps have been implemented:

1. New access openings were created to enable placing an ROV on top of each convection bundle.
2. The radiant box has been isolated.
3. All effluent and debris after cleaning have been collected and displaced to the ground level in sediment containers.

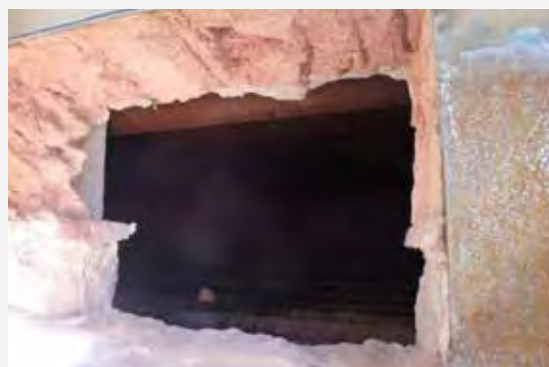
Figure 3. The external casing was cut up and a rectangular opening was created.

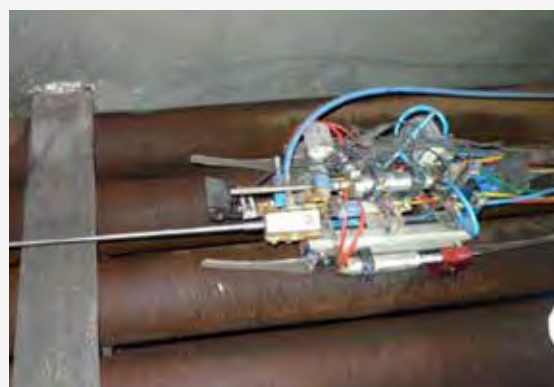
Figure 4. ROV on the top of the bundle.

The ROV technology entirely removed fouling from the convection bank coils. **The system removed 90%+ of fouling from all convection bundles.**

No refractory was damaged since ROVs are programmed to direct a high-pressure medium to the tubes only. All activities were done in 4x12-hour shifts.

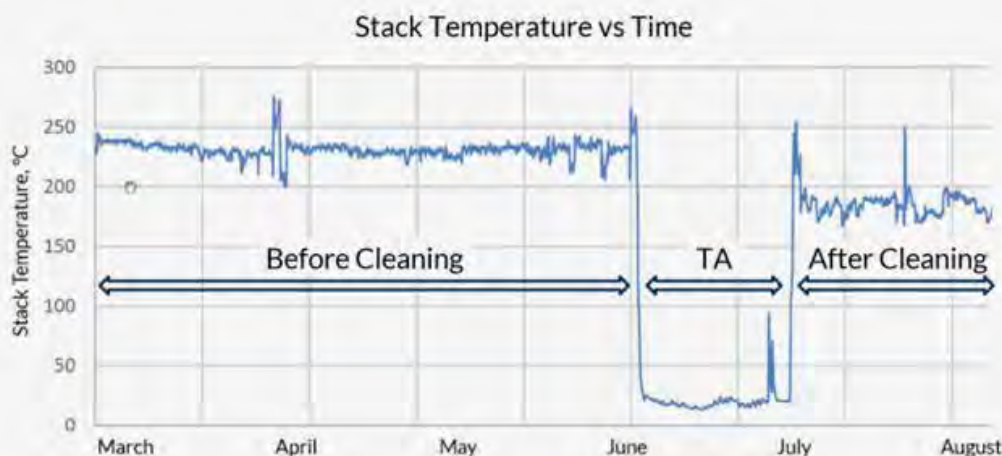
Figure 5. Stack Temperature Before and After Cleaning

Stack temperature has been used as a key performance indicator to identify and quantify the benefit after the project. **A sizeable benefit of a 40 °C drop in stack temperature has been achieved.** The plant reported a two percentage points

increase in **overall fuel efficiency from 89.5 to 91.5 on average leading to 2 MW fewer combustion losses** to the stack under the same capacity. The plant has reported a payback period of fewer than four months.

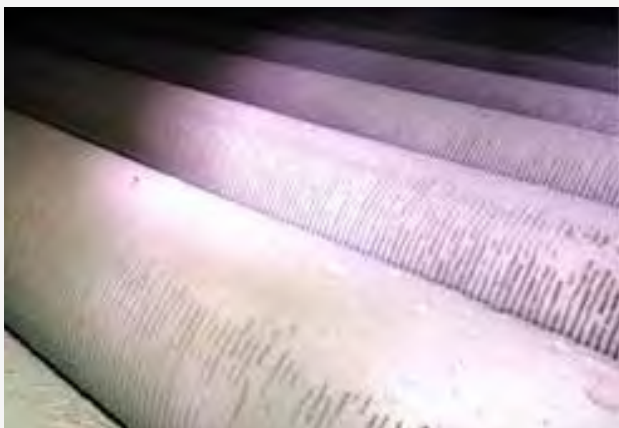
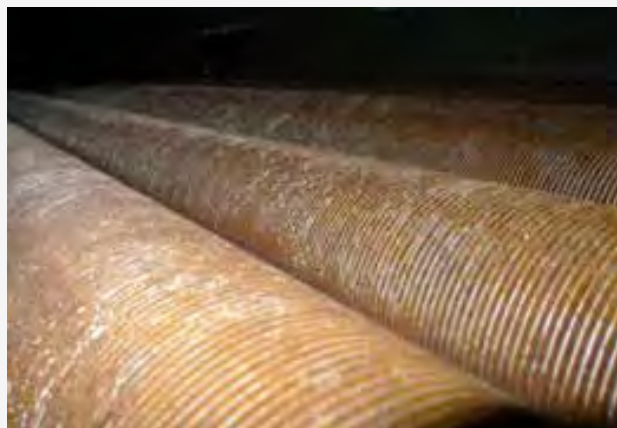
Figures 6&7. Before and After Fouling Removal Pictures. Part 1.

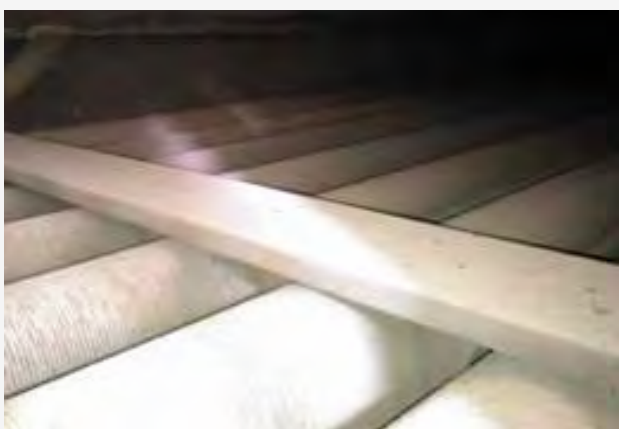
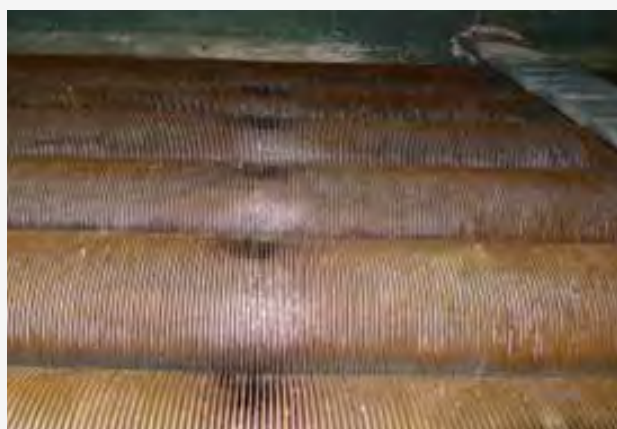
Figures 8&9. Before and After Fouling Removal Pictures. Part 2.
