Crude Distillation Unit Column Overhead Corrosion Protection

Abstract

High Velocity Thermal Spray, Crude Distillation Unit, Overhead Corrosion, Naphthenic Acid, Ammonium Chloride, Amine Corrosion

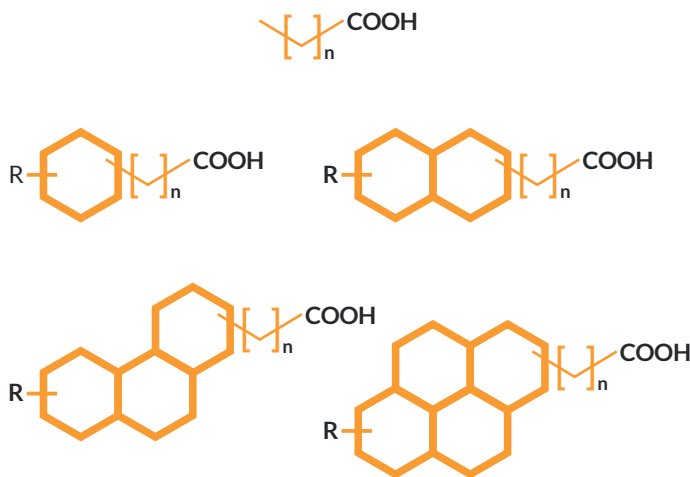
n-Cetyl mercaptan	$\text{CH}_3(\text{CH}_2)_{15}\text{SH}$
n-Decyl sulfide	$\text{CH}_3(\text{CH}_2)_9\text{S}(\text{CH}_2)_9\text{CH}_3$
Di-n-octyl disulfide	$\text{CH}_3(\text{CH}_2)_7\text{S-S}(\text{CH}_2)_7\text{CH}_3$
Dibenzothiophene

Figure 2: Common naphthenic acid (left) and organosulfur (right) forms found in crude oil ^{13, 14}

In contrast to overhead corrosion, naphthenic acid and sulfur species corrosion are high temperature phenomena, and typically occur in the lower to mid-column CDU area, resulting in wall thinning and corrosion on the condensation trays. Naphthenic acids (RCOOH) are complex groups of carboxylic acids that are naturally present in crude oils, ground water, and oil sands. These acids become corrosive on carbon steel around 180-220°C, then become increasingly corrosive as temperature increases, with a maximum corrosion occurring between 280 and 385°C. Above 400°C Naphthenic acids break down and no corrosion occurs. Generally, the naphthenic acid content is quantified in the crude oil TAN, with a TAN of greater than 0.5 indicating potential corrosivity.^{6,11,12}

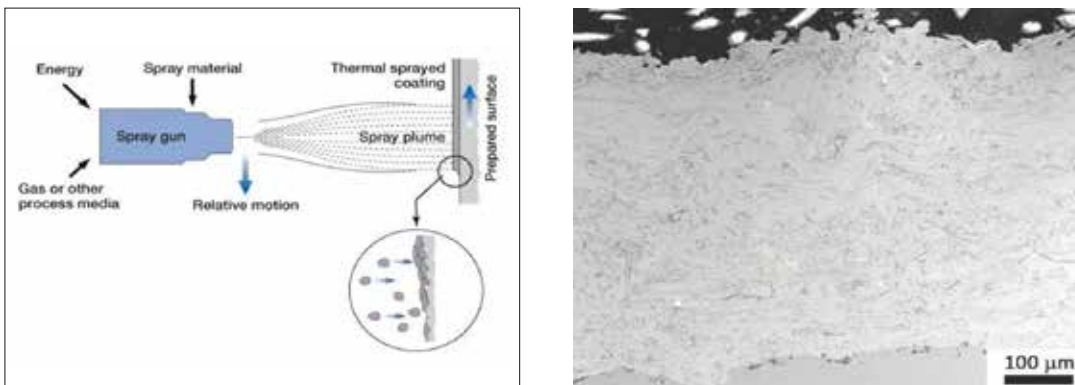
Figure 3: Example HVTS process diagram (left) and typical HVTS microstructure (right)

To protect against CDU corrosion, novel High Velocity Thermal Spray (HVTS) systems were explored as a solution. HVTS is a corrosion mitigation technique where a corrosion resistant metal alloy is atomized and the droplets conveyed at high velocity to a substrate such as carbon steel. On impact they form flattened 'splats' and sequentially build up cladding thickness. This metal coating, commonly based on NiCrMo/Nb/W super-alloys with alloy modifiers specifically required for thermal spray processes, forms a corrosion resistant and mechanically superior barrier over the carbon steel substrate. Prior limitations of the technology have been addressed with alloy modification to eliminate inter-particle connected porosity and shut down any corrosion path to the base metal. Further alloy modification is required to enhance bond strength and reduce native as deposited stress state. Although material design is a key parameter in successful application; conveyance equipment, process controls, procedure qualification and technician certification are equally critical to providing large surface coverage and protection.

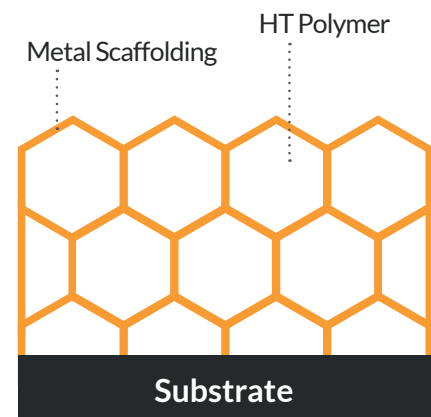
Figure 4: Table 1 of test alloys (left) and a typical MRP idealized structure (right)

HVTS Systems were selected based on current NiCrMo-XX thermal spray cladding systems (designated 5450 and 5470) and a newly developed cladding technology called Metal Reinforced Polymer systems (MRP®500)+. This hybrid system employs a preformed porous titanium alloy cermet scaffolding, microfused to the substrate, and imbued with a tightly structured, high temperature polymeric system to provide improved corrosion resistance in a diverse range of environments. Control systems for the test included uncoated UNS G10180 carbon steel as well as an unmodified UNS N04400 thermal spray alloy used as a traditional weld overlay and thermal spray system.

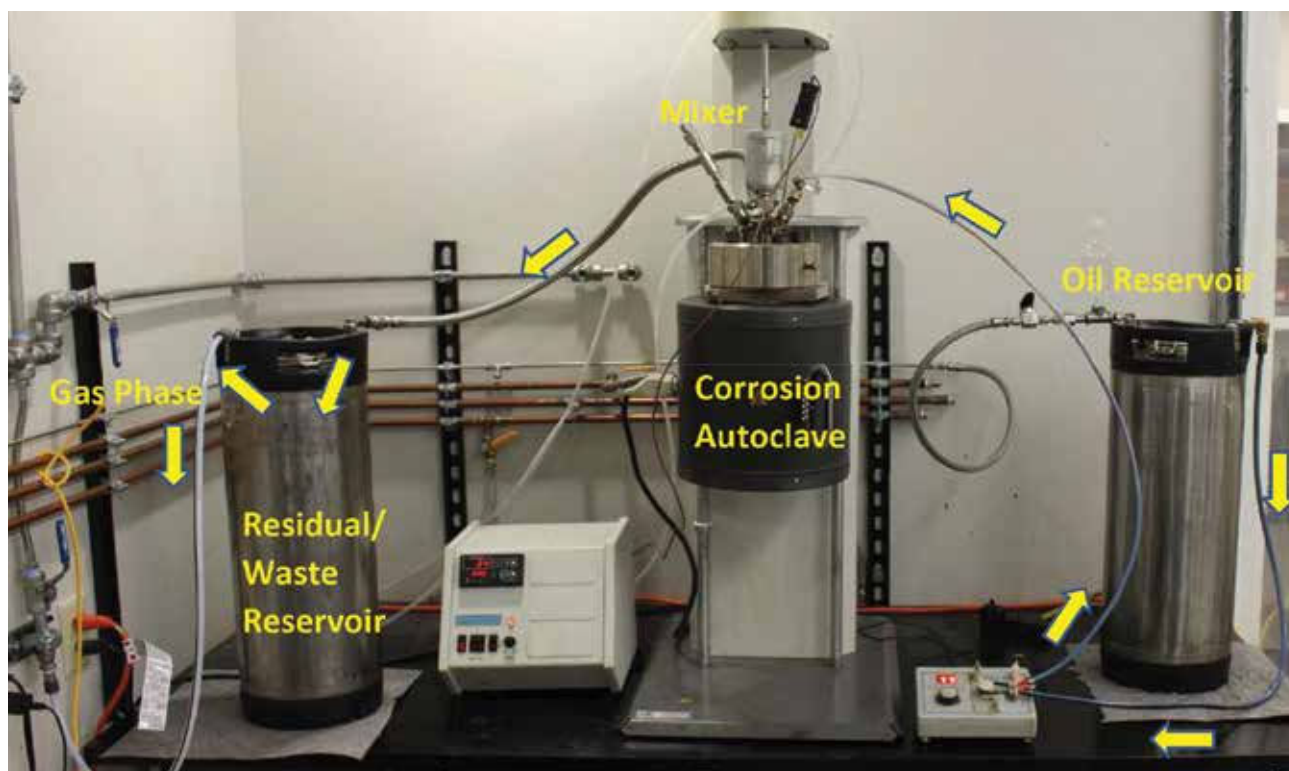
Figure 5: High temperature naphthenic acid and sulfidation autoclave setup

A corrosion autoclave was used to test coupons in a high temperature naphthenic acid and sulfidation environment. Enhanced crude oil was stored in a reservoir under atmospheric temperature and pressure and continually fed into a 700 ml stainless steel autoclave through a positive displacement peristaltic pump. A low volume nitrogen feed was used to prevent the formation of a vacuum in the oil reservoir, with an air lock used to release excess nitrogen and prevent a pressure build. A mixer was run continuously at approximately 45 RPM to prevent separation and the accumulation of heavy crude fractions such as tar in the vessel. Specialty autoclave test coupons were fixed to the shaft, ensuring they were always exposed to fresh media and flowing crude oil. Spent crude was collected in a waste reservoir, while vapors were drawn off into a gas disposal system. Both feed and waste reservoirs were respectively filled and emptied multiple times throughout experimentation to maintain continuous flow. The system operated at a temperature of 300°C for two weeks for exposure time.

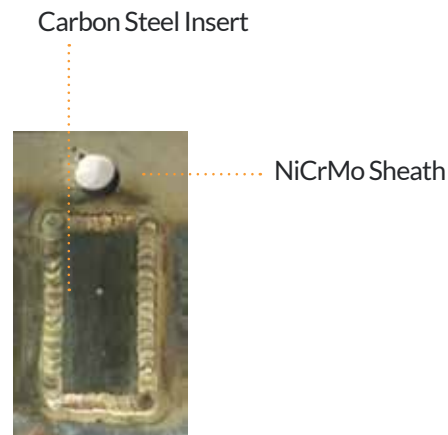
Figure 6: Table 3 of autoclave test conditions (left) and standard IGS Immersion Coupon (right)

Test coupons consisted of a carbon steel insert welded into a NiCrMo, UNS N06625 sheath. This coupon design, intended for immersion and autoclave corrosion studies, allows for a carbon steel exposure test area while eliminating edge-effect issues that can lead to non-experimental coating failure on small coupons. Before HVTs coating, cleaned and profiled with a high specification aluminum oxide abrasive blast media. A profilometer was used to confirm that the carbon steel plates were profiled correctly before applying IGS thermal spray and other cladding systems. Coating thickness was confirmed using an electromagnetic standoff gauge. Control coupons were blasted with a low-profile garnet blast media to remove mill scale but not significantly increase surface area. Following exposure, coupons were cross-sectionally analyzed.

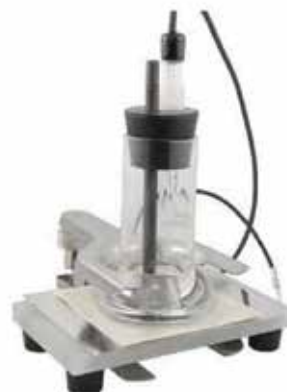
Figure 7: Table 5 of exposure cell test conditions (left) and standard exposure cell setup (right)

Evaluation of the overhead CDU corrosion environment, which takes place at lower temperatures and is primarily HCl and salt based, was performed using exposure cells. The test cell solution was a deionized water mixture of 1% HCl (resulting in a room temperature solution pH of 0.8), 2.5% NH₄Cl, and 2.5% Methylamine Hydrochloride (CH₃NH₂HCl), a corrosive amine salt used to represent the range of amine salts that can form. The cells were kept in a furnace at 95°C. Test coupons consisted of 2” x 4” carbon steel panels coated with the MRP and HVTS protective claddings. As with the autoclave coupons, all panels were cleaned and profiled with a high specification aluminum oxide abrasive blast media. Coating thickness was confirmed using an electromagnetic standoff gauge. Control coupons were blasted with a garnet blast media.

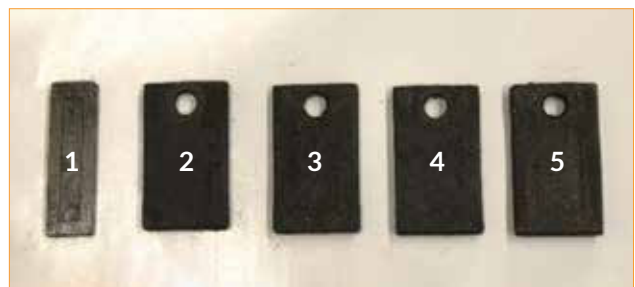
Figure 8: Table 8 of autoclave test results (left) and post-test coupons (right)

Following two weeks of exposure, coupons were removed from the corrosion autoclave and examined visually. The coupons were, as expected, covered in a layer of crude oil, which was removed with alcohol. The cleaned coupons remained stained black with dried crude, and limited observations could be drawn visually. Coupons were then cross-sectioned and analyzed via SEM EDS; pass/fail evaluations were determined based on the presence of any corrosive media at the cladding/carbon steel bond line or in the cladding, as well as any active corrosion.

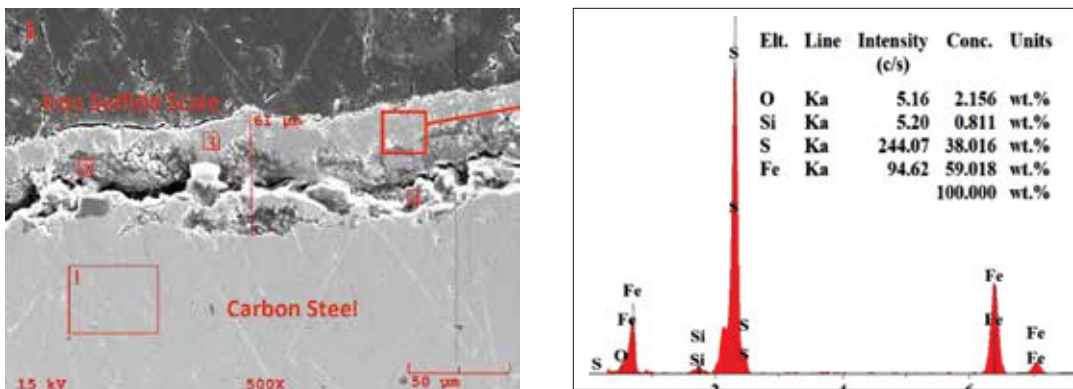
Figure 9: Control coupon corrosion scale (left) and EDS analysis (right)

The cross-sectioned control coupon, a test surface of uncoated carbon steel within a NiCrMo sheath, showed a continuous corrosion scale approximately 50 – 75 μm (2-3 mils) in thickness. The scale was not universally well adhered, and in locations, the carbon steel surface showed additional evidence of pitting and granular corrosion. The scale itself was predominantly iron sulfide, with low levels of iron oxide, suggesting that, in this specific setup, iron sulfidation was the primary driver of corrosion over naphthenic acid. As previously noted, iron sulfide scale can be easily destroyed by oxidation or naphthenic acid corrosion, and will not necessarily slow down continuing corrosion or provide protection.

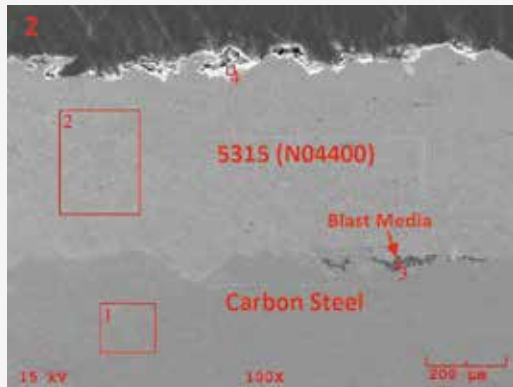
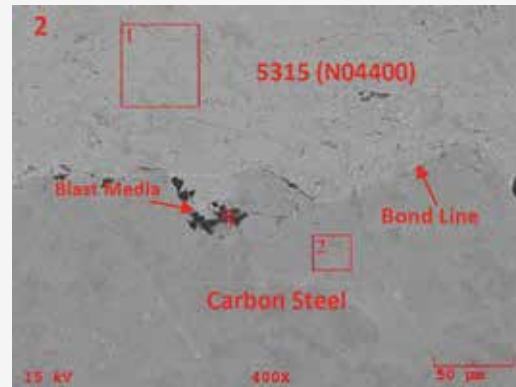
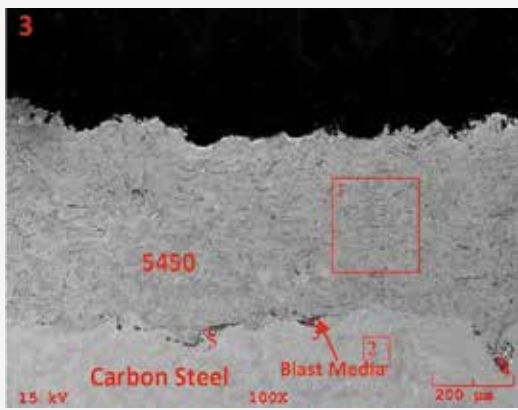
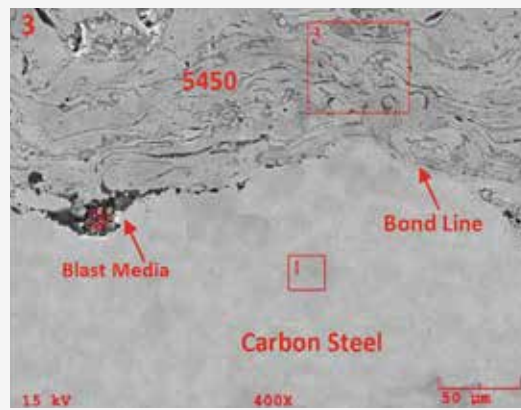
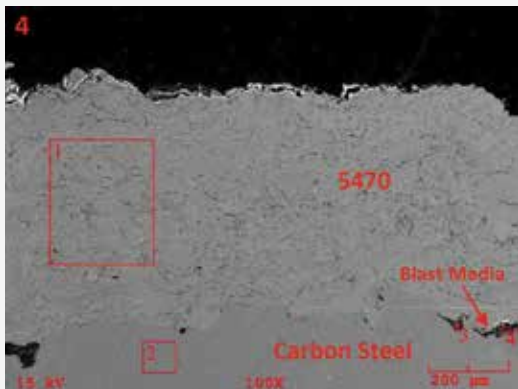
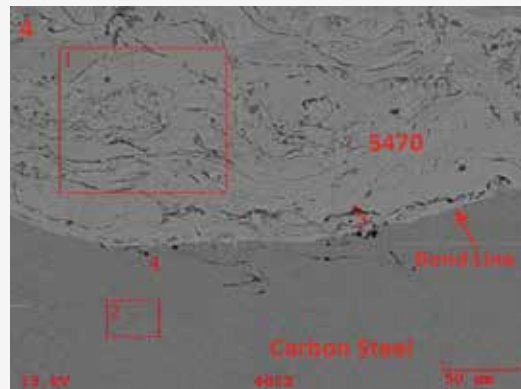
100X Bulk Imaging

400X Bond Line Imaging

Figure 8: Table 8 of autoclave test results (left) and post-test coupons (right)

As with the control coupon, the four experimental coupons were cross sectioned for analysis. Imaging and elemental analysis of the bulk coating systems was performed to ascertain the microstructural condition of the claddings, verify that the composition and oxide levels are within specification, and detect any corrosive media that has penetrated. Additionally, higher magnification images were taken at the bond line between the carbon steel and claddings, where corrosion and cladding disbondment is frequently seen. Results indicated that microstructural composition was within specification and all coatings were well-adhered. Some imbedded aluminum oxide blast media, used for surface profiling, can be seen at the carbon steel; this is considered normal and does not impact coating quality or adhesion. Porosity seen in the MRP system is also normal and a feature of the polymer filled metal scaffolding. No corrosion or corrosive media was seen at any of the bond lines, with no indication of HVTS or MRP degradation. Ultimately, all coatings passed the autoclave corrosion testing.

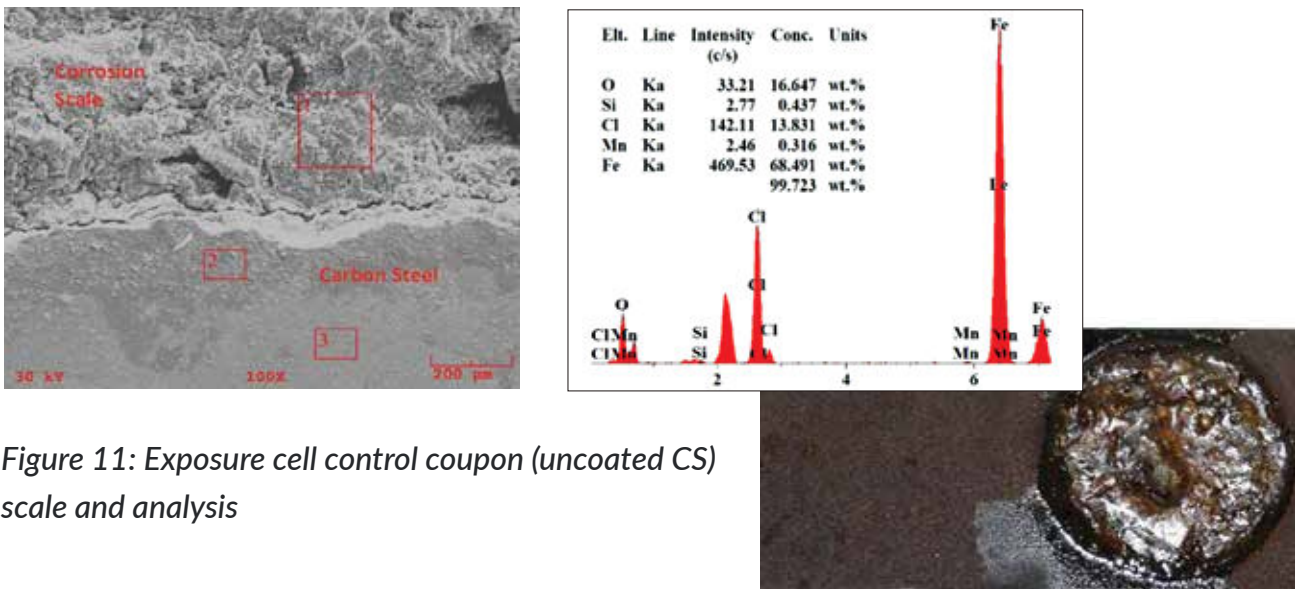
Figure 11: Exposure cell control coupon (uncoated CS) scale and analysis

Panels were inspected daily. Within 24 hours of exposure, the uncoated carbon steel test coupon showed the formation of a brown corrosion scale, which continually grew in thickness and density. After removal, the control corrosion scale was approximately 2 – 2.5 cm (0.5 – 1.0 in) thick. This scale was preserved using a clear, high wetting epoxy to protect it through the sample cutting and preparation process. SEM EDS confirmed that the scale was a mixture of iron chloride and iron oxide, and substantial material wastage had occurred. The rapid scale growth confirms the corrosivity of the test environment. The level of iron chloride noted confirms that a low oxygen level was maintained in the system and prevented breakaway oxidation.

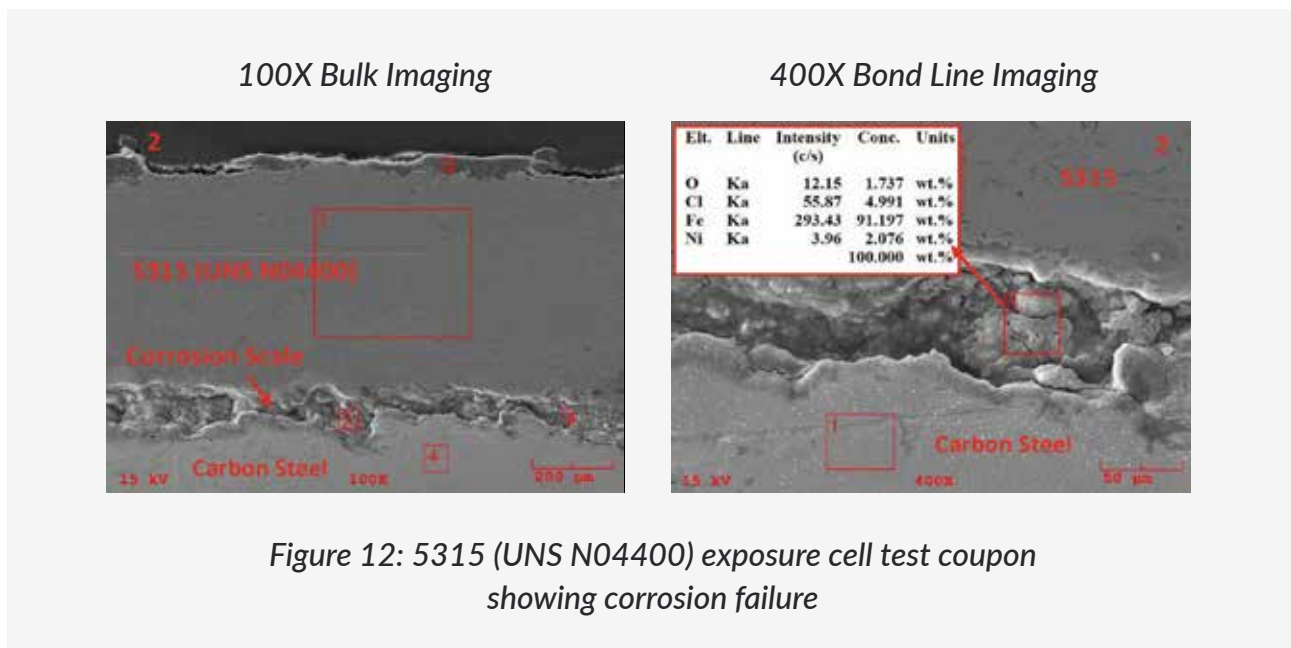
Figure 12: 5315 (UNS N04400) exposure cell test coupon showing corrosion failure

As with the autoclave coupon analysis, cross-sectional imaging and EDS focused on HVTS microstructural form and composition, adhesion, and any corrosion scale at or near the bond line. SEM imaging revealed a corrosion failure on the 5315 (UNS N04400) system, with the formation of iron chloride-based corrosion scale at the bond line and partial disbondment of the cladding. The 5315 system is not alloy modified for thermal spray application. Intersplat adhesion is consequently poor, which when coupled with solidification stress, decreases interfacial adhesion of the system and results in fine permeation pathways. It is possible that excess porosity and nanometer sized intersplat cold lapping allowed for corrosive media, specifically chlorine, to penetrate the system and attack the interface.
