SCR & LPA Screen Efficiency: Case Study and Results

APS Four Corners

Written by: Andrew Kline (IGS Director of Technical Sales), Jessica Hernandez (APS – Senior Environmental Engineer), Zachary Shadoan (IGS – Proposal Manager)

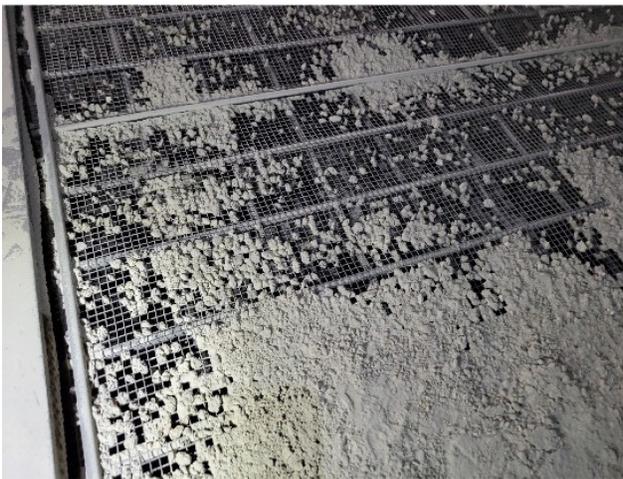
LPA Found in SCR

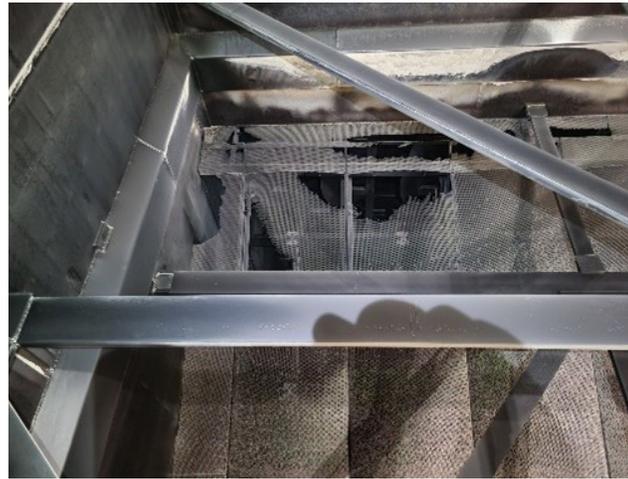
LPA Erosion due to Increased Velocities

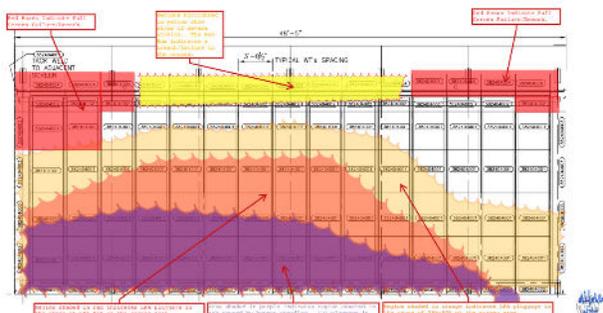
Inspection Map Showing Ash Piling

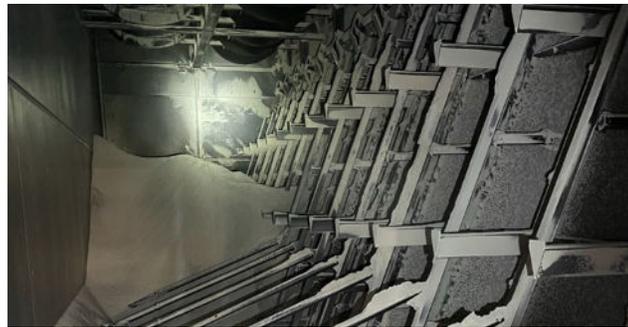
Ash Piling on LPA Screens

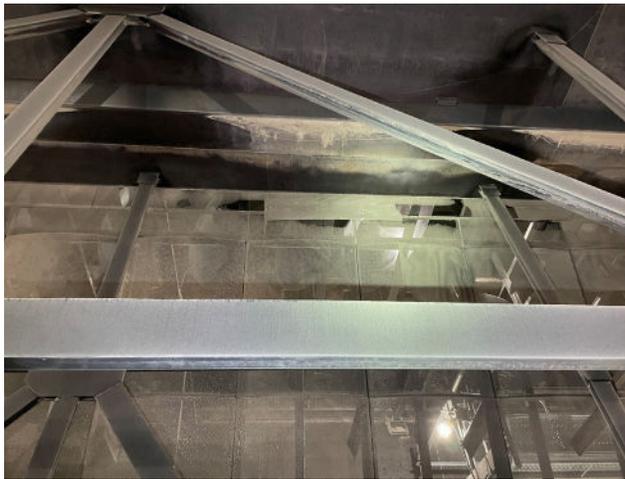
Erosion on LPA Screens Caused by Increased Flue Gas Velocities

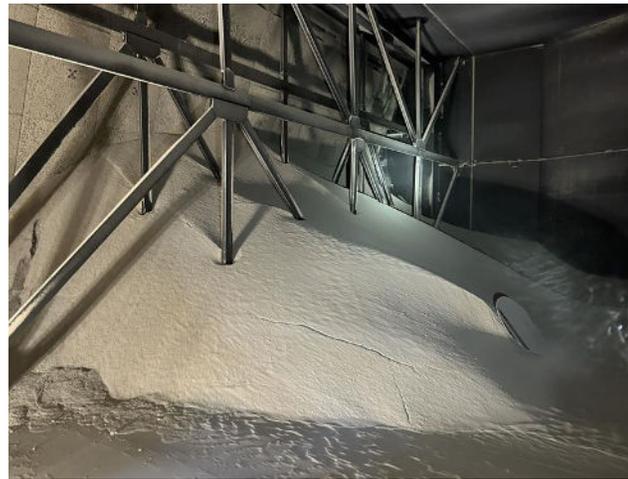
LPA Screen Ash Piling

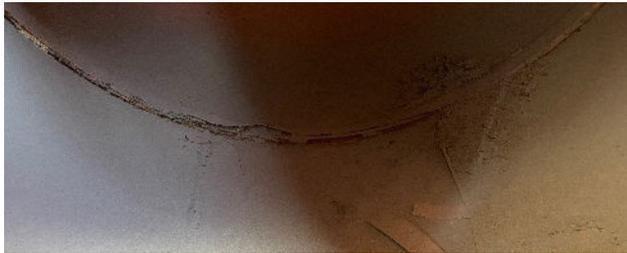
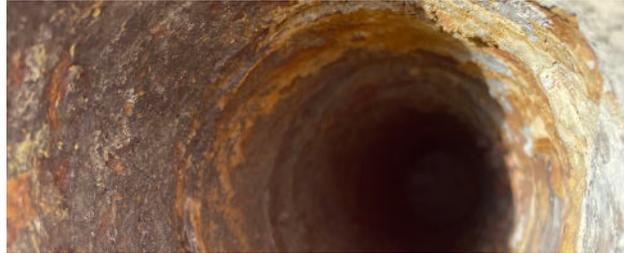
Positive pressure also became an issue for the supporting equipment as it took its toll on the SCR air cannons, discharge piping, and firing assemblies. The air cannons were operating ASME pressure vessels, but appeared to have suffered significant interior corrosion.

Many air cannons were found to have pinhole leaks in their tanks and discharge piping, and some had even fallen off of the SCR wall due to piping structural failures. Not only did this impact cleaning performance, but this was a significant safety concern. All air cannons would have to be replaced prior the expected end of the plant life of 2031.

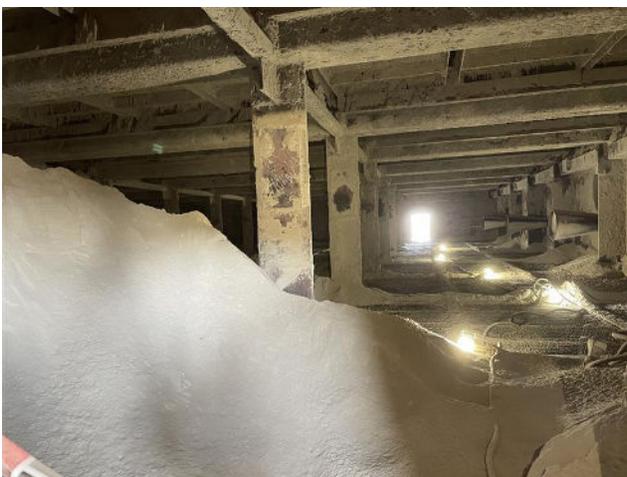
Piling due to Inoperable Air Cannons

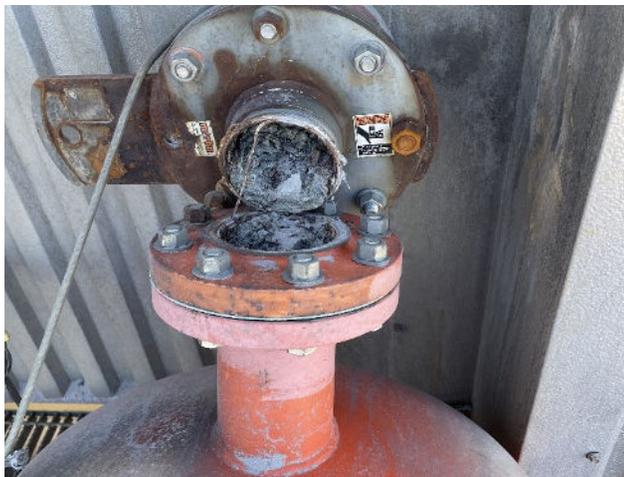
The thin threaded carbon steel metal was corroding quickly due to the exposure to atmosphere, allowing the air cannons to break off the unit during a discharge. These findings were significant safety concerns and the maintenance became intensive and difficult, which limited the overall effectiveness of the system. The most cost effective solution was to replace the entire system as soon as possible.

Failure of Air Cannon Discharge due to Corrosion

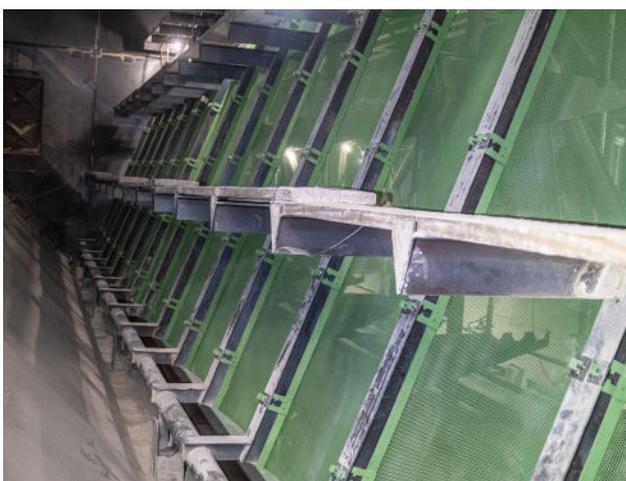
Replaced LPA Screens with Bolt in Scaffold Brackets

The LPA screen panels were completely replaced in both Units 4 and 5. The coating material was upgraded to the IGS Two-Stage coating to provide additional erosion protection, but more importantly allow for a quick visual inspection for future maintenance.

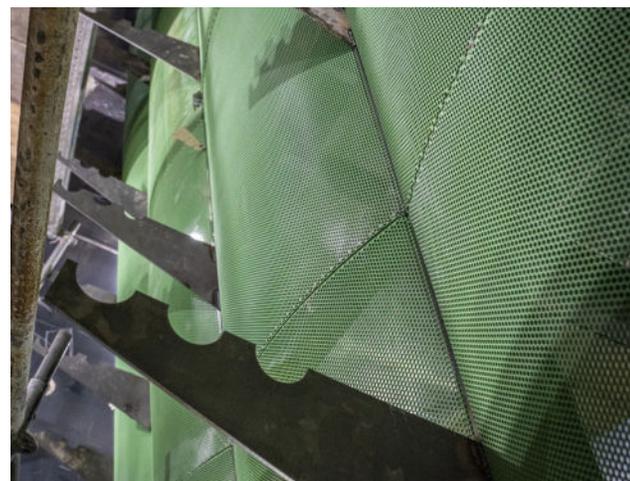
New LPA Screen Panels with Upgraded Two-Stage Coating

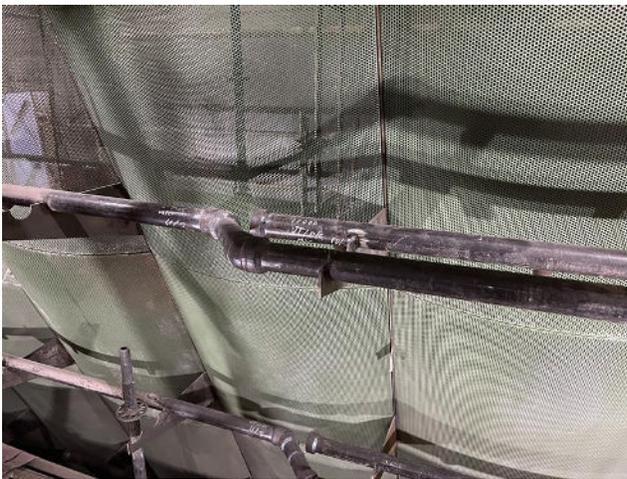
Air Cannon Header Nozzle on Screen

To accommodate, IGS recommended and replacing the outdated rapper cleaning system with an LPA screen air cannon cleaning system. This system was better suited to handle the upset flow conditions caused by potential ash piling, and was also able to help re-entrain and redistribute the fly ash pile, helping to slow its growth and improve the effectiveness of the hopper vacuuming ports.

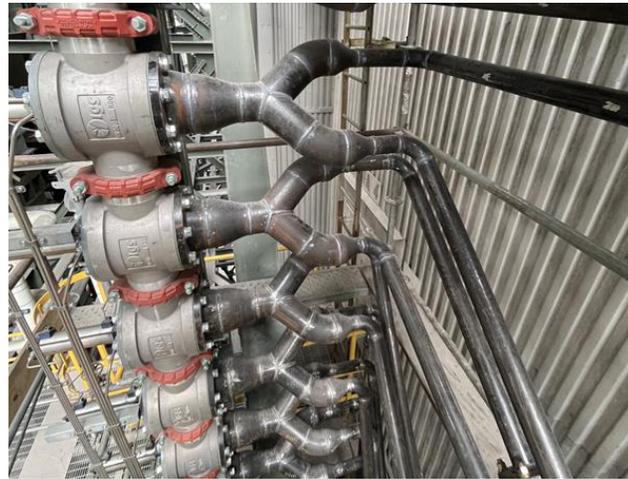
Air Cannon Multipliers

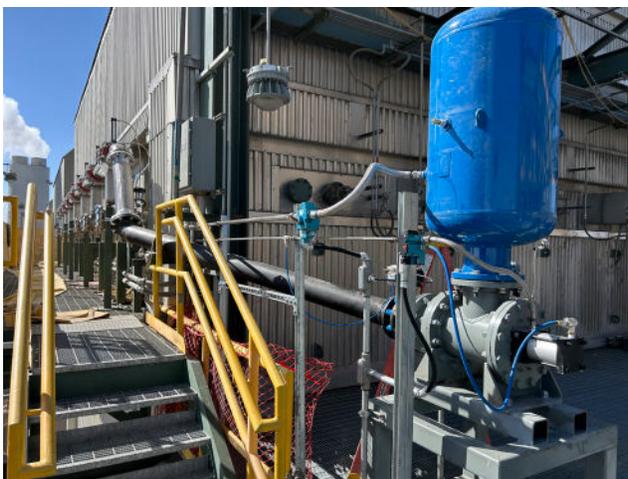
Upgraded SCR 8" Big Blue Air Cannon

To improve cleaning performance, the system was upgraded from 150L 4 inch air cannons to an 300L 8 inch air cannon. This dramatically increasing cleaning power and distance in the reactor. Additionally, the nozzles were changed from a narrow blast to a more powerful yet wider spreading blast.

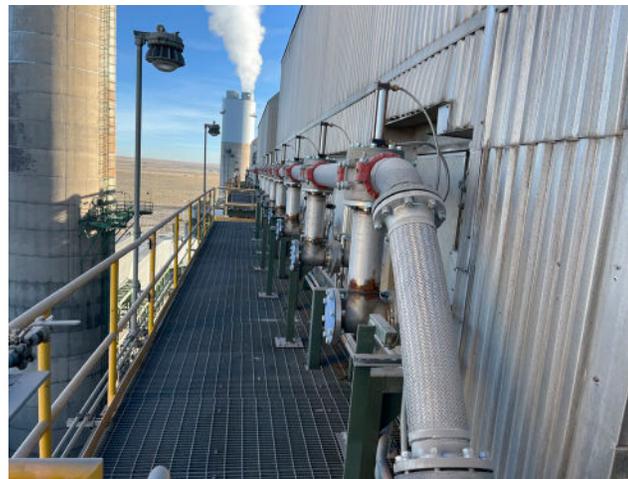
Air Cannon Multipliers

IGS designed and supplied an air cannon system specifically designed for positive pressure SCR units on both Units 4 & 5. Firstly, IGS moved to the IGS Multiplier system, which reduced the ASME pressure tanks from 32 per unit to 4 per unit. This also distanced the critical pressure air cannon components away from the process and the multiplier system added a protective layer between the process and the air cannon itself. This dramatically reduced the maintenance requirements while also making the system more resilient the challenges of a positive pressure unit.

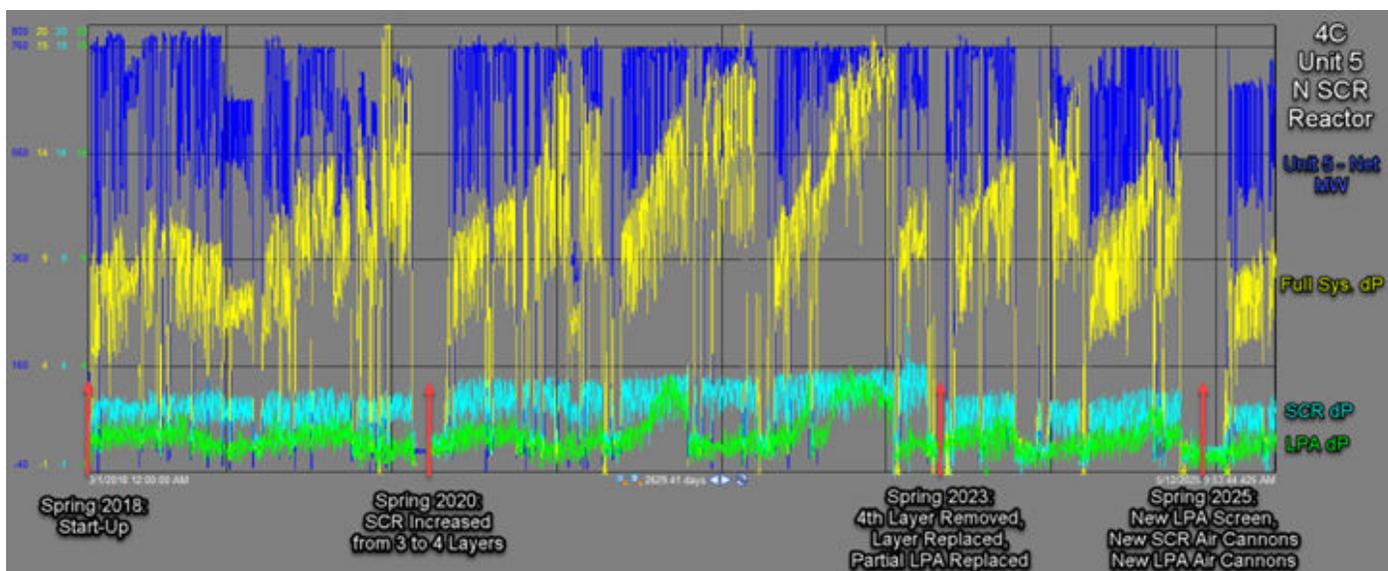
Below is an illustration of pressure drops of Unit 5 North and South from initial startup in March 2018 all the way to the present-day data of April 2025. Marked improvements can be seen in LPA dP, SCR dP, and full system dP, especially after the implementation of upgraded systems in Fall 2024.

System Pressure Drop Data Before and After Installation

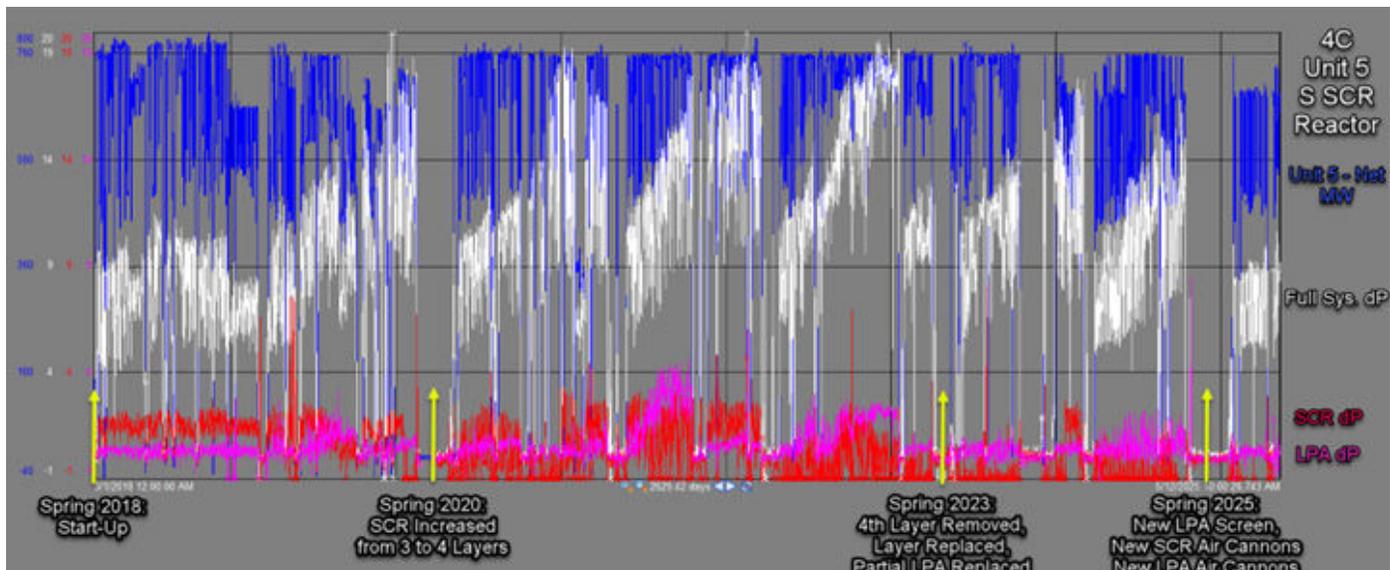
System Pressure Drop Data Before and After Installation

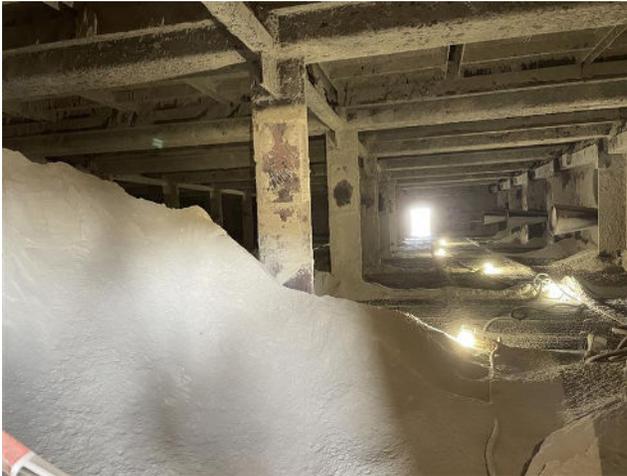
LPA Piling

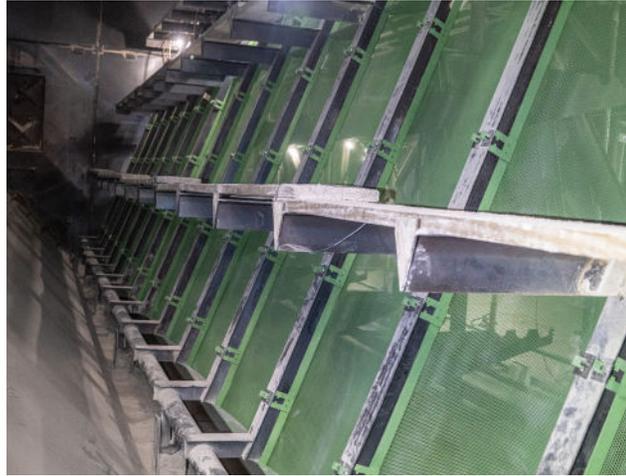
IGS LPA Screen Prevents Piling

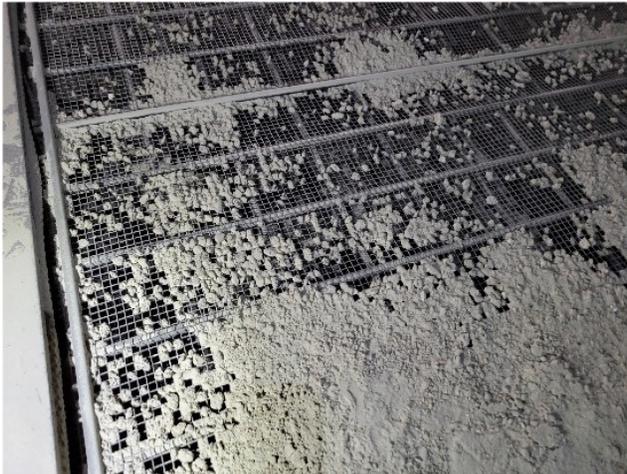
LPA Found in SCR

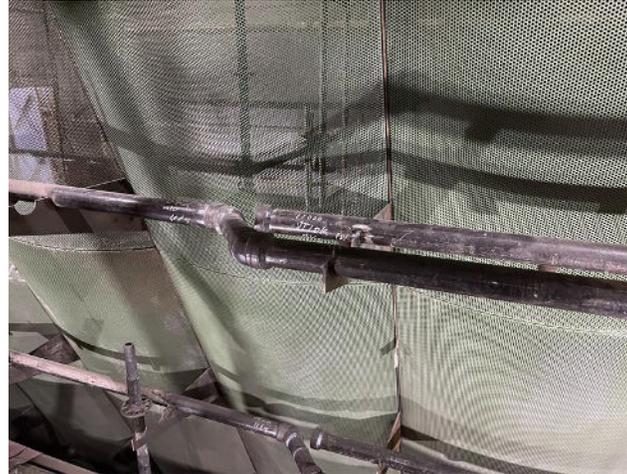
Clean SCR Guarantee

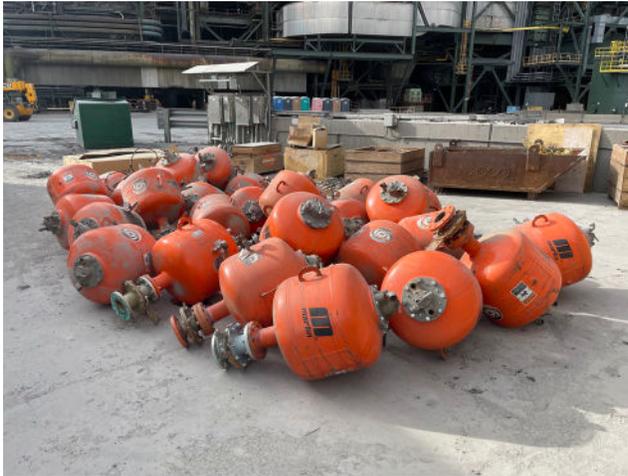
Inoperable Air Cannons

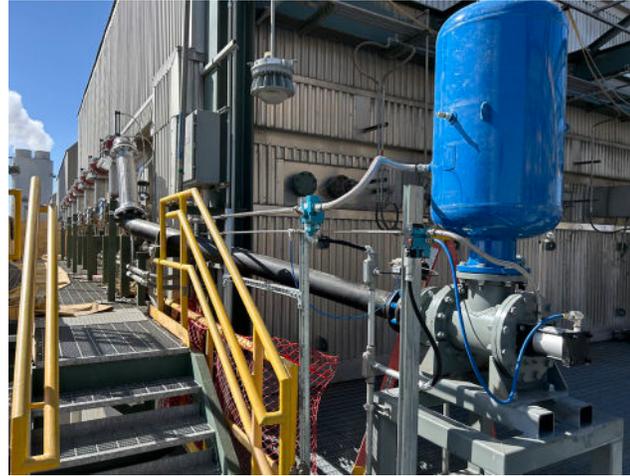
IGS Big Blue Air Cannon

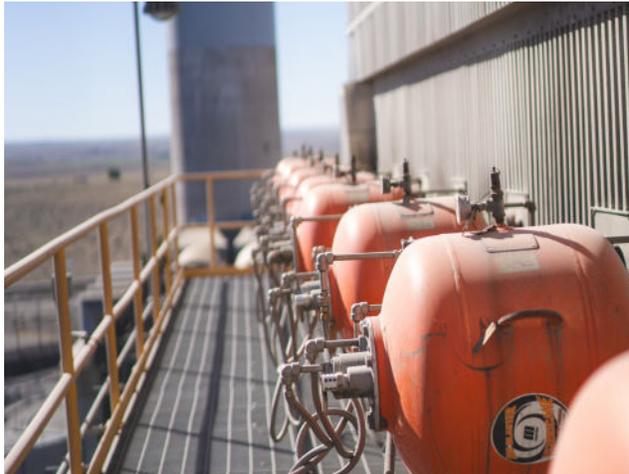
Multiple Air Cannons

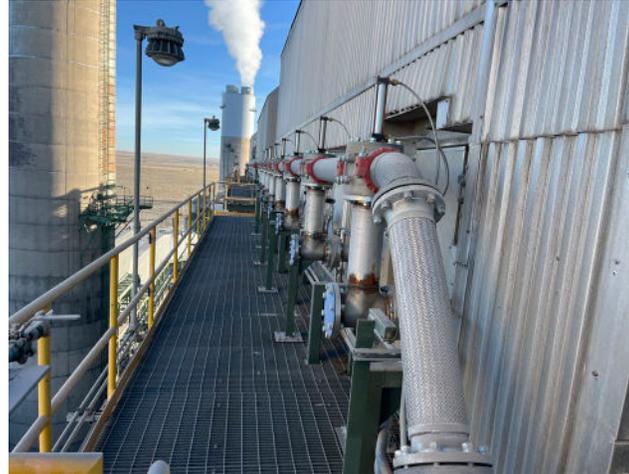
Air Cannon Multiplier System
