HVTS PREVENTS CORROSION ATTACK IN A REGENERATOR COLUMN AT LNG PLANT IN GCC

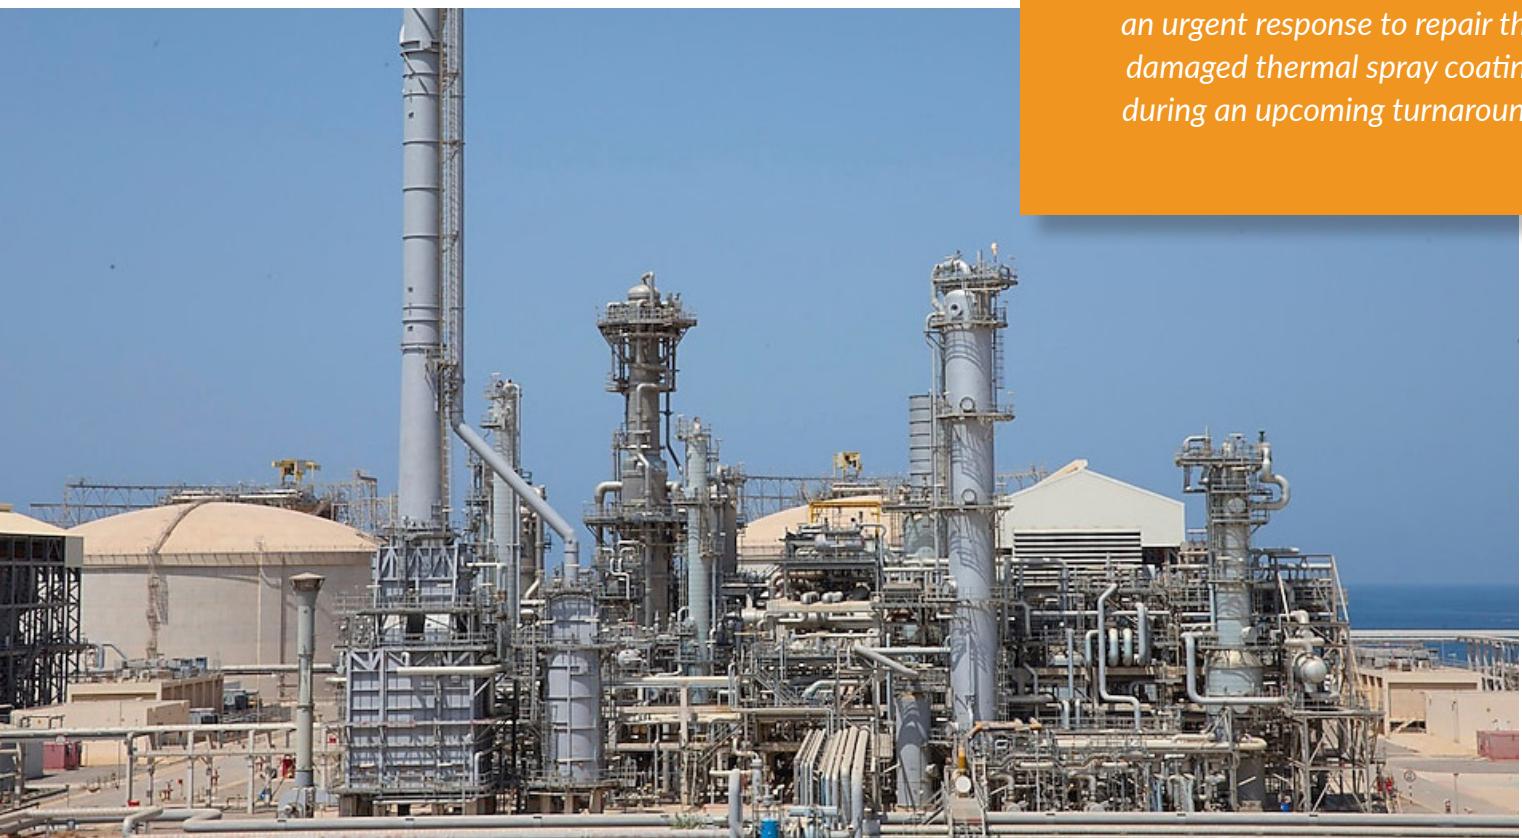
The inspection found numerous coating failures across the upper and lower chambers with visible micro-cracking and blistering apparent.

IGS removed the failed thermal spray coating in regions with micro-cracking, blistering, spalls, and delamination. Once completed, the shell substrate surface condition was inspected, and surface preparation was carried out by IGS technicians.

Once the surface was prepared correctly, IGS applied its own uniquely developed High Velocity Thermal Spray (HVTS) cladding, with more than 40m² of IGS HVTS cladding applied onsite, on time and at the highest quality standard.
